Station 3 Evaluation

GBC DESIGN, INC.
ARCHITECTURE AND ENGINEERING

GBC Project No. 47216

**CUYAHOGA FALLS
FIRE STATION NO. 3**
SUMMARY ASSESSMENT
1601 PORTAGE TRAIL
CUYAHOGA FALLS, OHIO 44221

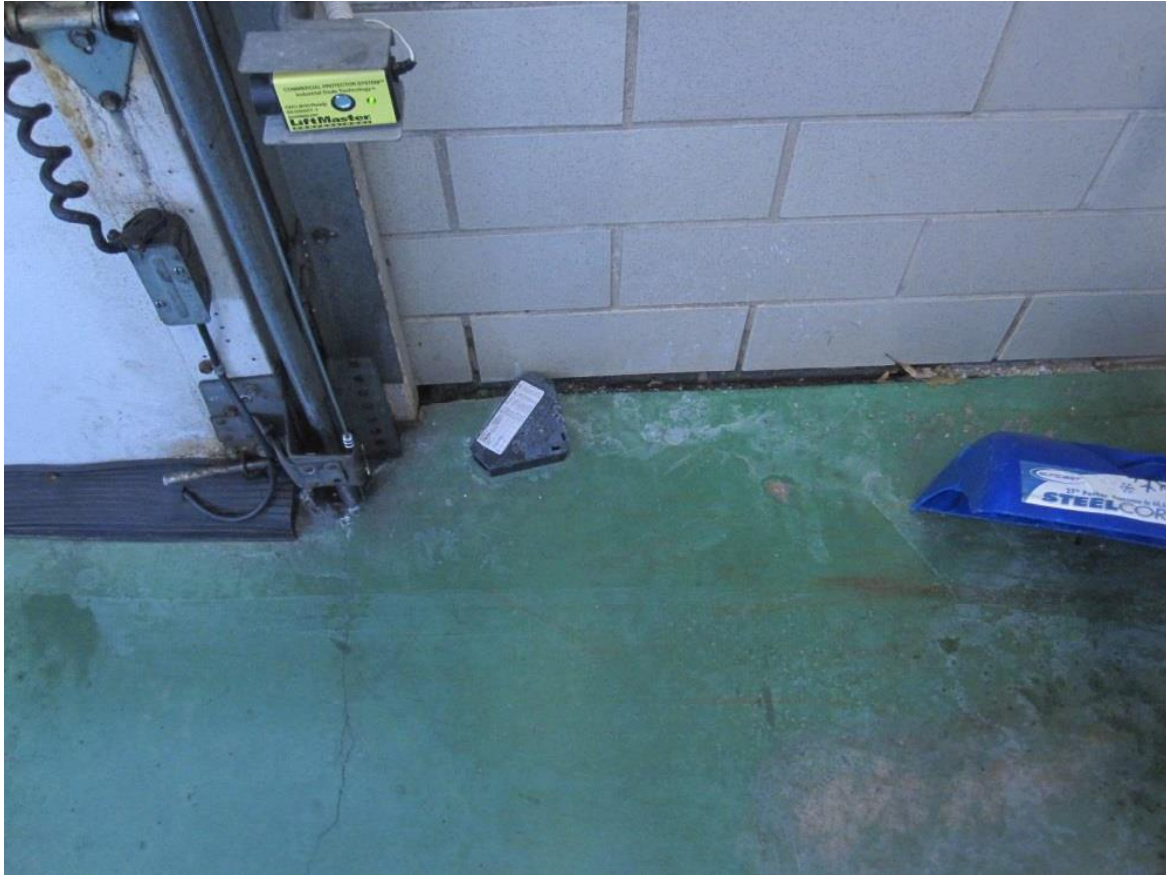
ARCHITECTURAL PICTURE 1:
Floor settlement at south wall. No visible floor or wall cracking.

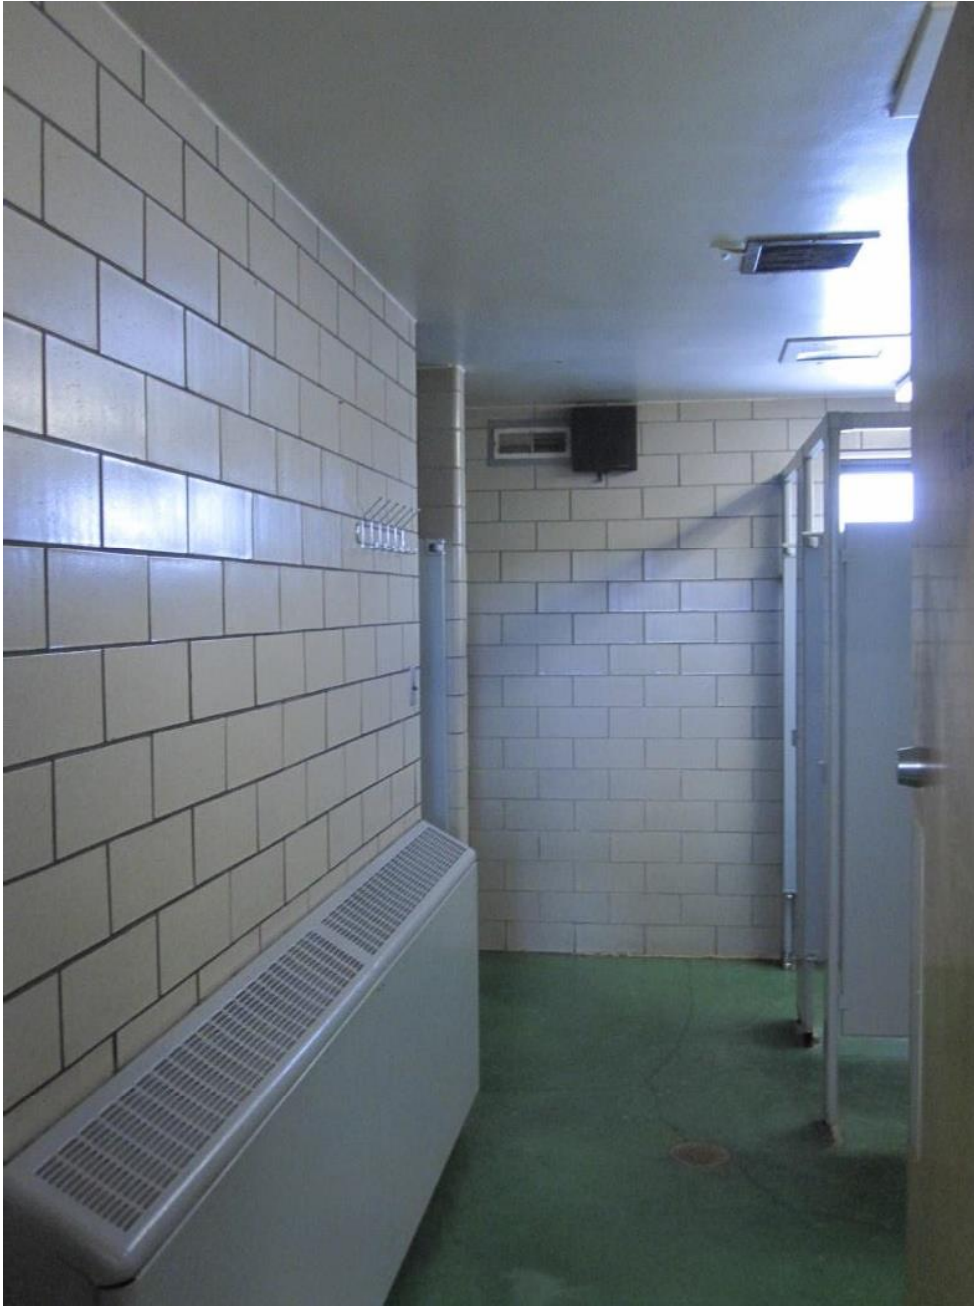
ARCHITECTURAL PICTURE 2:
Limited space in restroom. All interior walls concrete masonry and glazed block.

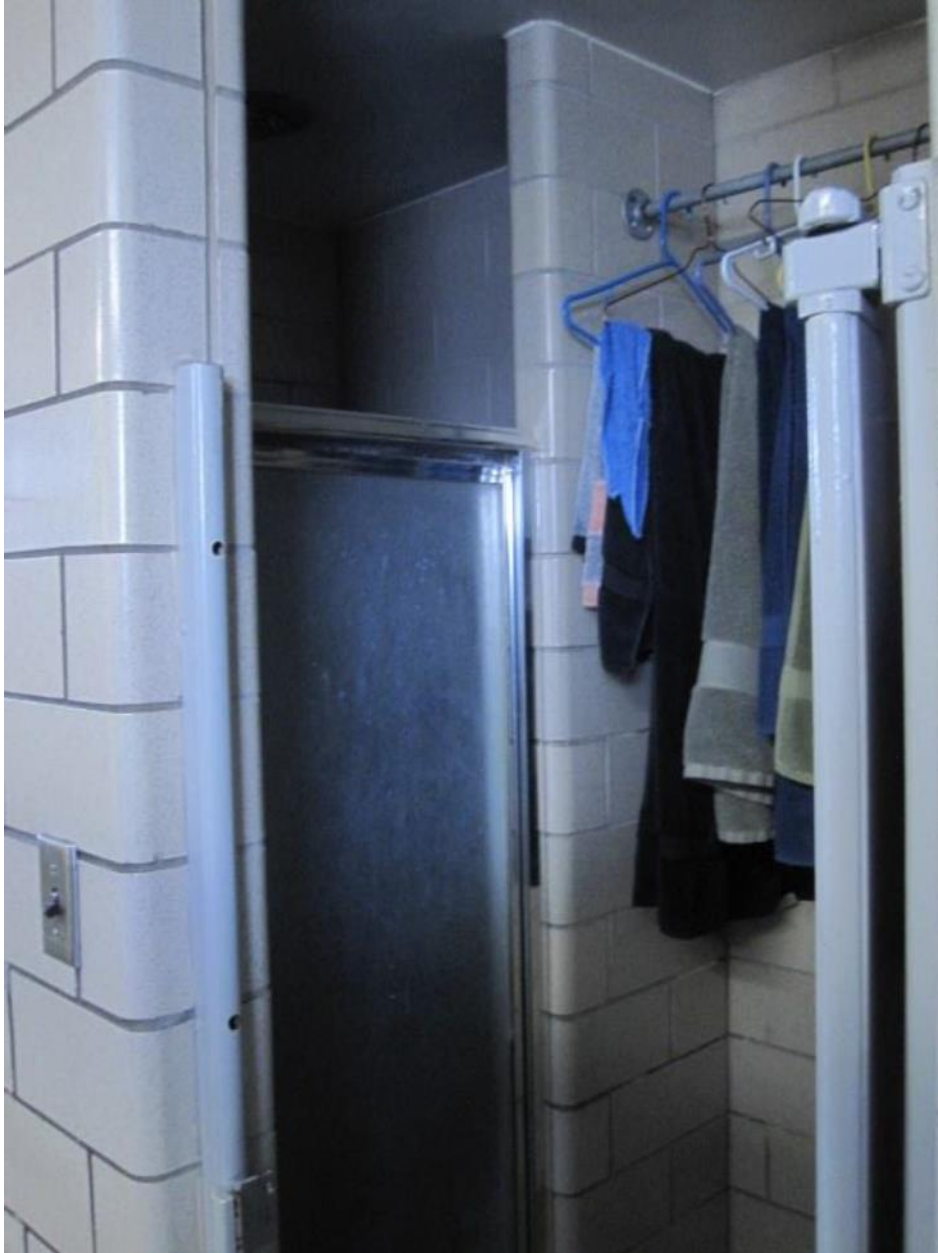
ARCHITECTURAL PICTURE 3:
Narrow shower clearances not compliant with ADA/ANSI codes.

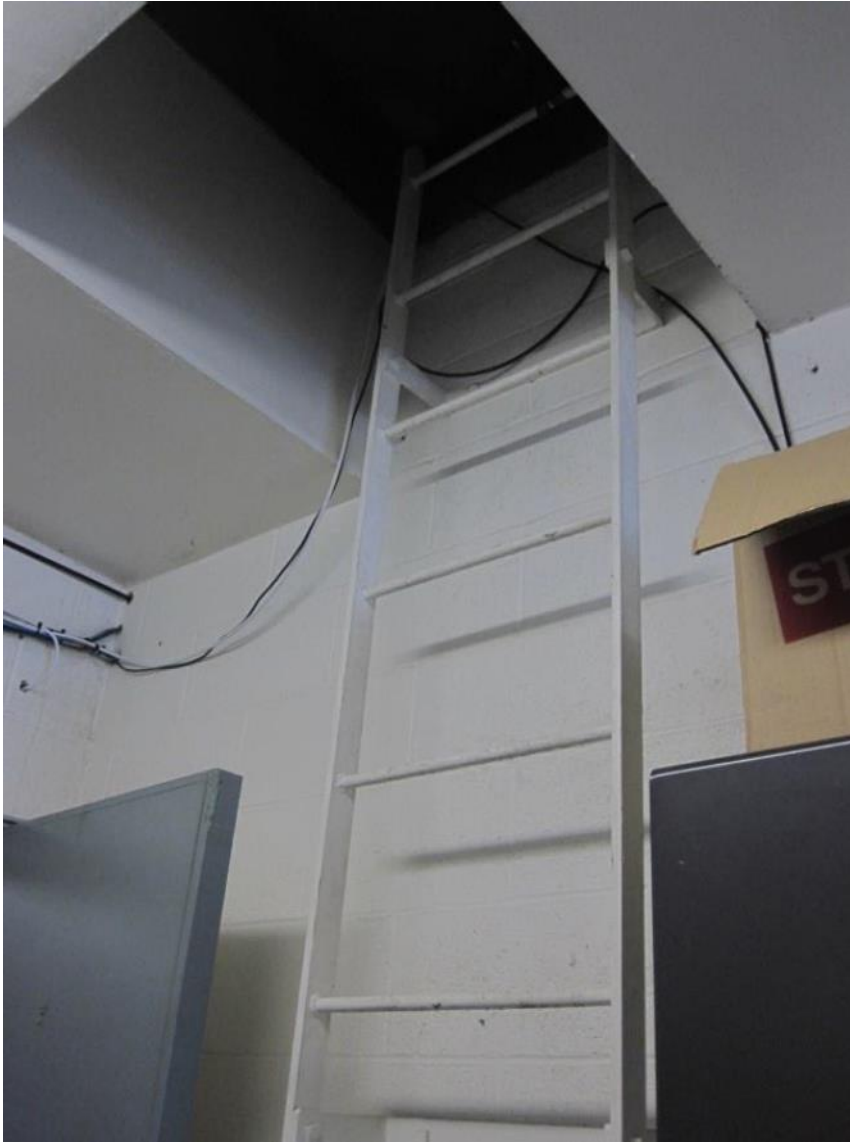
ARCHITECTURAL PICTURE 4:
Ladder access to roof

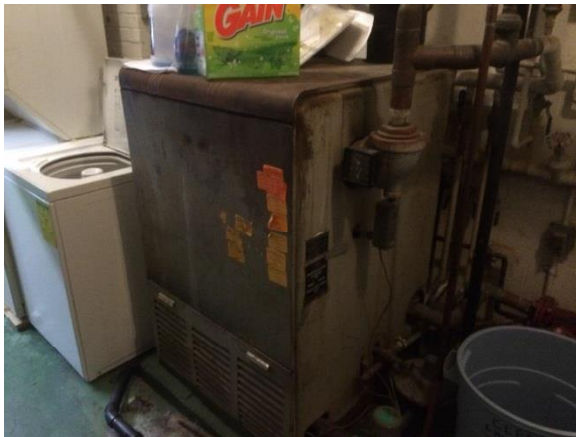
HVAC Pic 1

- The building is heated by the original Bryant hot water boiler, model 8-446, with an output capacity of 422.4 MBH. This boiler is 56 years old and has passed its recommended life span. See HVAC pic 1 picture.

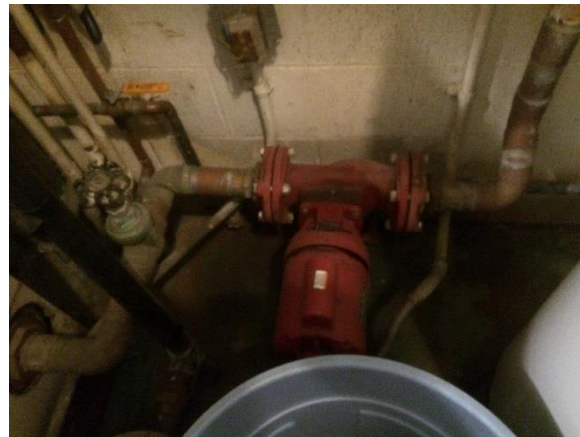
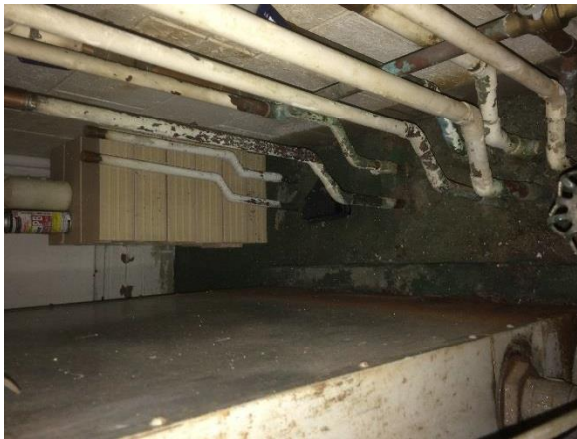
- Hot water is circulated through the building by one Bell & Gasset pump, model SEAL SRG 1891C, with a 1/4 HP motor. The hot water piping is copper and it is routed above the ceiling and under the floor to the mechanical equipment. The motor was replaced in 2005. See HVAC pic 2 and HVAC pic 3 pictures.

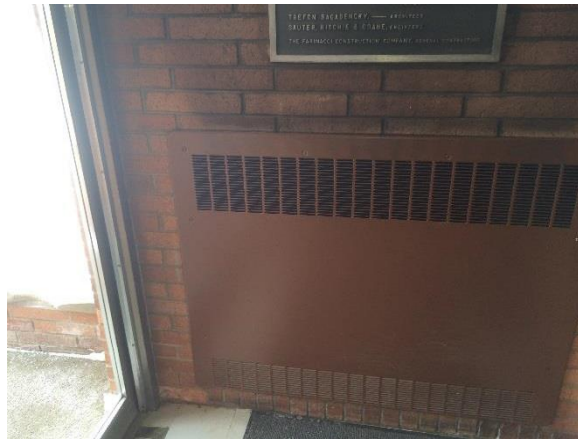
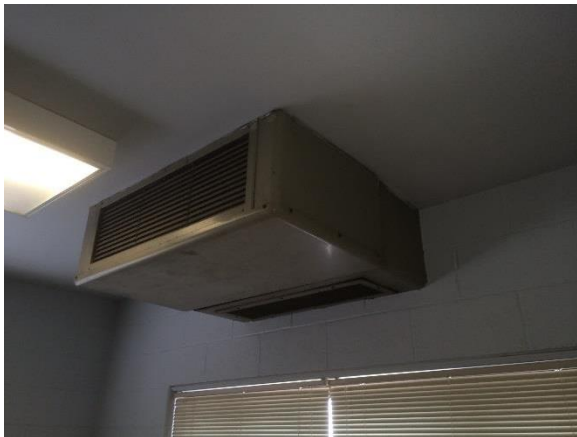
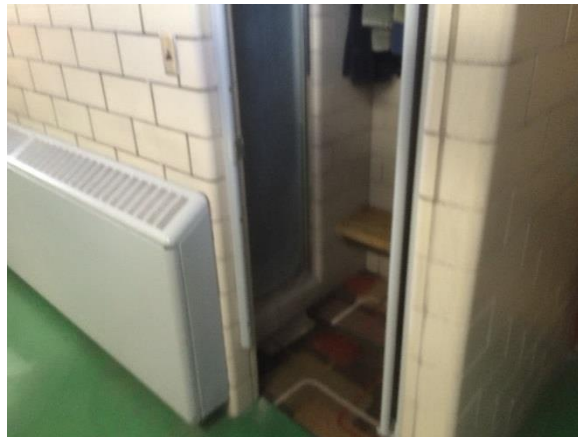
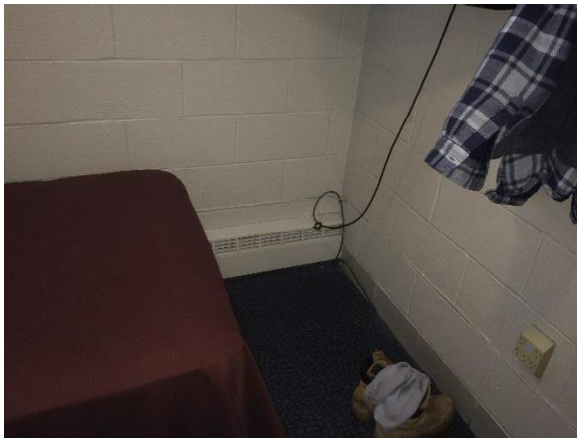
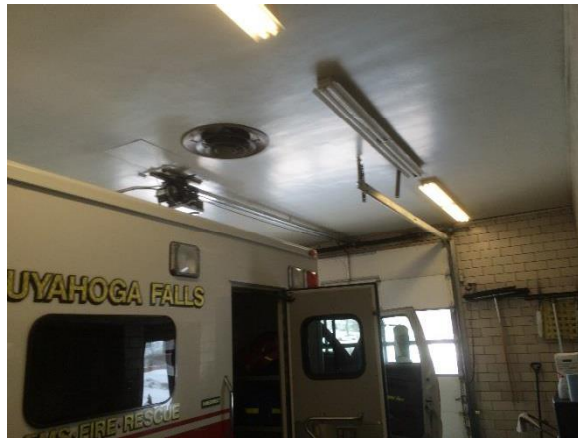
- The hot water HVAC equipment is original and provides heating only. This equipment includes cabinet heaters, fan coil units, and fin tube. See attached HVAC pics 4, 5, 6, 7, and 8.

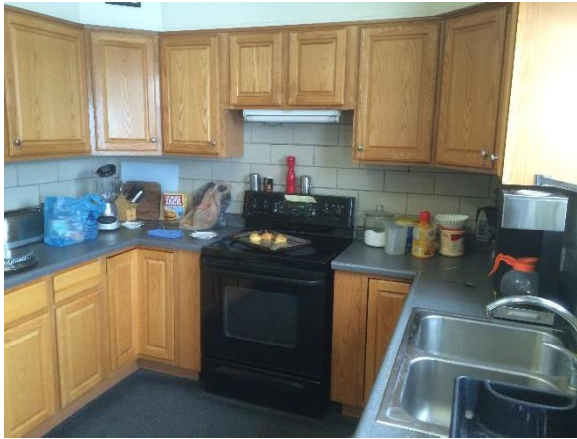
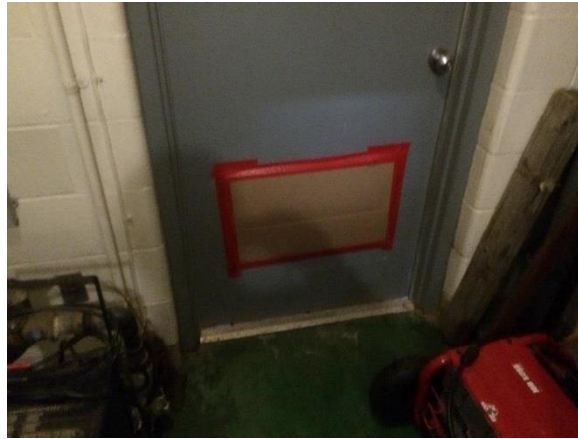
- The cooking range/over does not have an exhaust hood. See HVAC pic 15.
- The boiler room does not have combustion air from the outside for the firing of natural gas for the boiler. See HVAC pic 16.

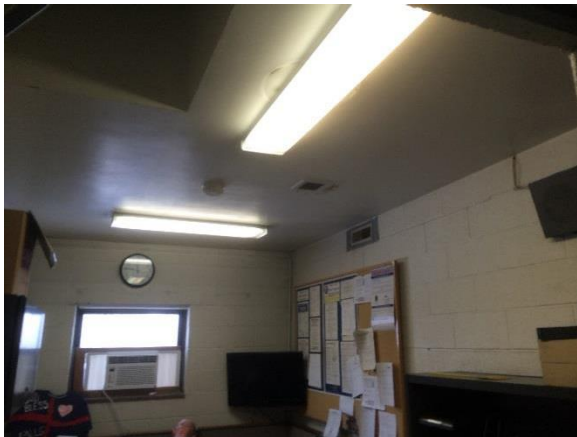
HVAC Pic 17

- The office has a window air conditioner. See HVAC pic 17.

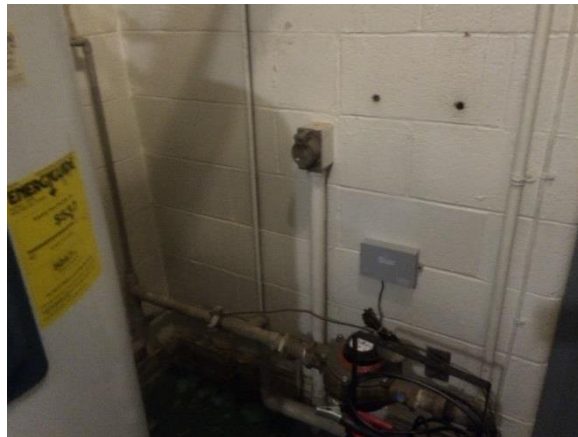
Plumb Pic 1

- The building has a 2 inch diameter domestic water service. The water meter is located in the boiler room. This service does not have a main backflow preventer. See Plumb pic 1.

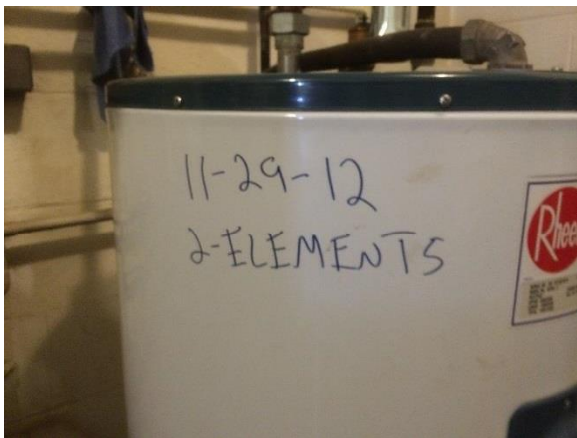
Plumb Pic 2

- Domestic hot water for this building is supplied by a Rheem electric water heater, model 82V80-2, with an 80 gallon storage tank and 4,500 watt electric heating element at 240 volt electrical service. The unit was manufactured in February 2010. It looks like it was installed in November 2012. This heater is in good condition. See Plumb pic 2.

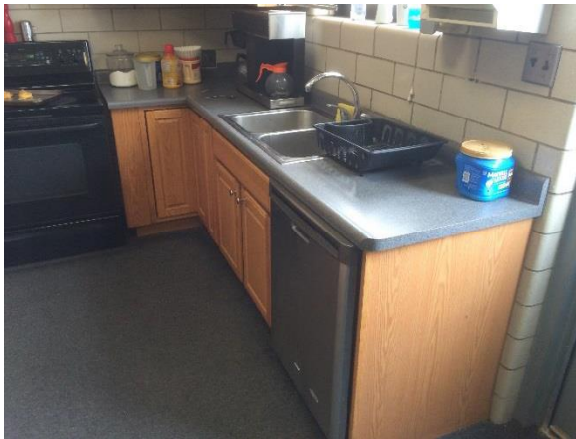
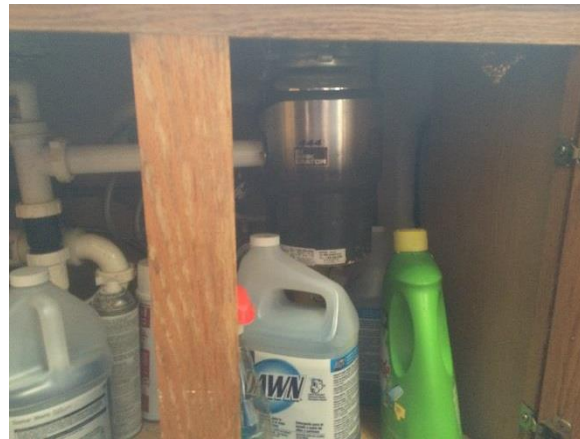
- The kitchen has a stainless steel double bowl sink (with a garbage disposal) and a dishwasher. See Plumb pics 4 and 5.
- One truck has a stand-a-lone air compressor. See Plumb pic 6, 7, and 8. This compressor also supplies one shop hose reel.

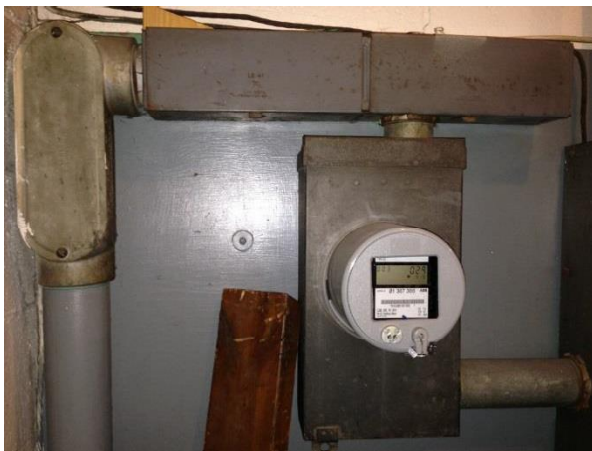
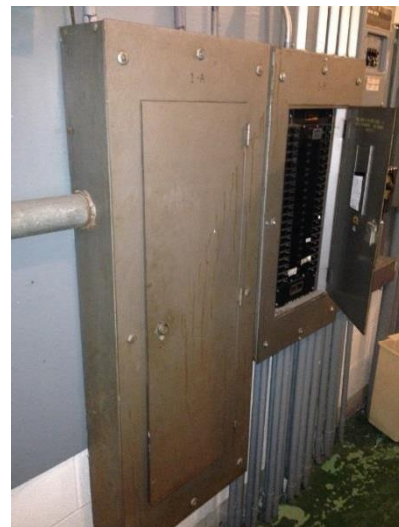
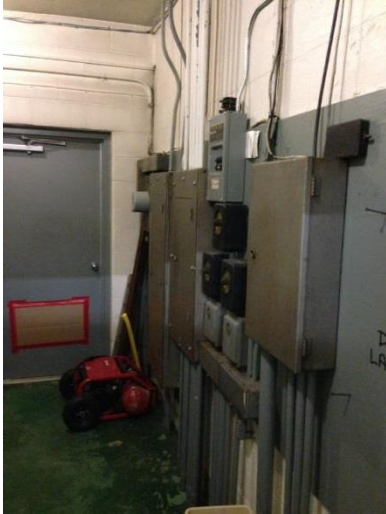
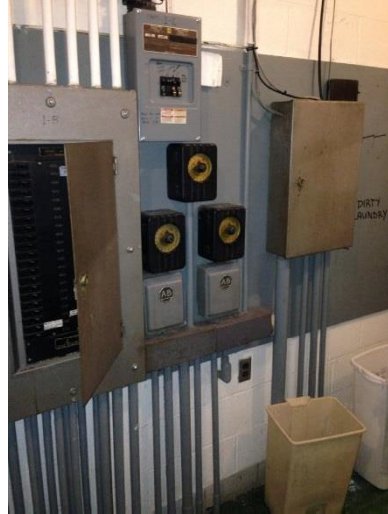
- It appears all of the electrical distribution equipment is located within the utility room. The main distribution panelboard "1-A" contains a main breaker and is rated for 175Amps at 120/240V, 1-phase, 3-wire. The main distribution panelboard also contains a 150A sub-feed breaker which feeds additional loads/breakers within the main distribution panelboard as well as other panelboards within the utility room. The existing electrical gear appears to be original to the building. The manufacturer of the electrical gear is ITE. It is recommended the electrical gear be replaced due to the equipment being at the end of its design life and no longer being manufactured. (See Electric Pics 1,2,3,4)

- Existing panels "1-B" and "1-C" are located within the utility room adjacent to the main distribution panelboard "1-A". The existing panel "1-B" appears to be original to the building. The manufacturer of the electrical panel is ITE. It is recommended the electrical panel be replaced due to the equipment being at the end of its design life and no longer being manufactured. Existing electrical panel "1-C" appears to have been added into the electrical system during a previous renovation. The panel appears to be a 4-circuit "residential load center" and is fed from an existing breaker within panelboard "1-B". It is being used to power the cord reels and lighting. (See Electric Pics 1,2,3,4)

- The available breaker space within the existing panelboards does not exist. There are no spaces available to add additional breakers/circuits.
- Based upon the configuration and capacity of the existing electric service, we recommend the existing electric service and electrical distribution equipment to be upgraded and replaced with new if the building is renovated or expanded upon.

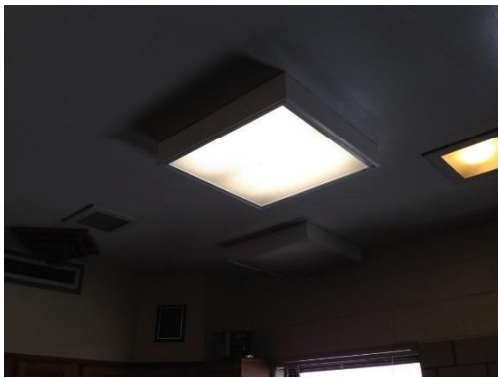
Lighting Pic 1

- The interior light fixtures located in ancillary spaces such as utility rooms and closets appear to be outdated. It appears that most of the surface mounted fixtures in these areas are original to the building but their respective halogen or incandescent lamps have been replaced with self-ballasted fluorescent spiral type lamps to conserve energy. (See Lighting Pics 1)

- It appears that in some areas (dorm rooms & kitchen area) the original recessed light fixtures were replaced with surface mounted 2'x2' U-lamped fluorescent fixtures. (See Lighting Pics 1)
