**PUBLIC INVOLVEMENT AND PRELIMINARY DESIGN OF THE  
REHABILITATION/REPLACEMENT OF THE RIVERFRONT  
BOARDWALK**

**DEVELOPMENT OF A PUBLIC INVOLVEMENT STRATEGY AND  
PRELIMINARY ENGINEERING FOR THE REHABILITATION/REPLACEMENT  
OF THE RIVERFRONT BOARDWALK**

The City of Cuyahoga Falls owns and maintains a riverfront boardwalk structure running along the west bank of the Cuyahoga River, near the downtown Falls River Square area. At the request of the City, Palmer Engineering performed a field inspection of the boardwalk structure in October and November of 2019. During the inspection, pier settlement and joist hanger failures were observed which compromise the safety of the public. Due to these observations, Palmer recommended partial closure of the boardwalk in the areas of concern, and the City closed the recommended areas shortly thereafter.

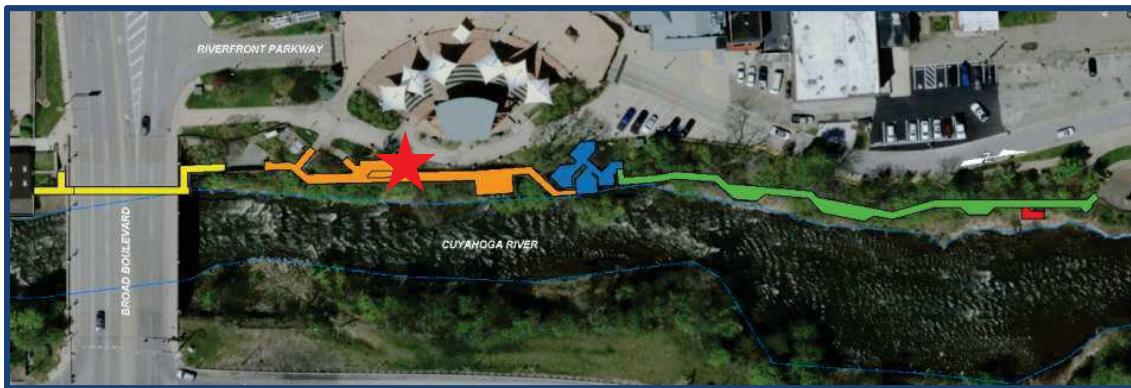
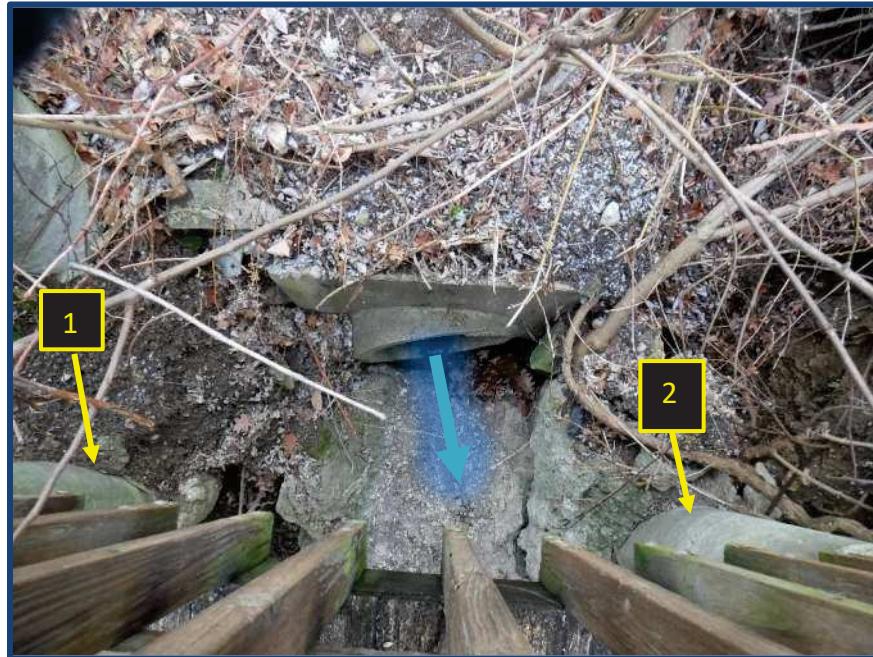
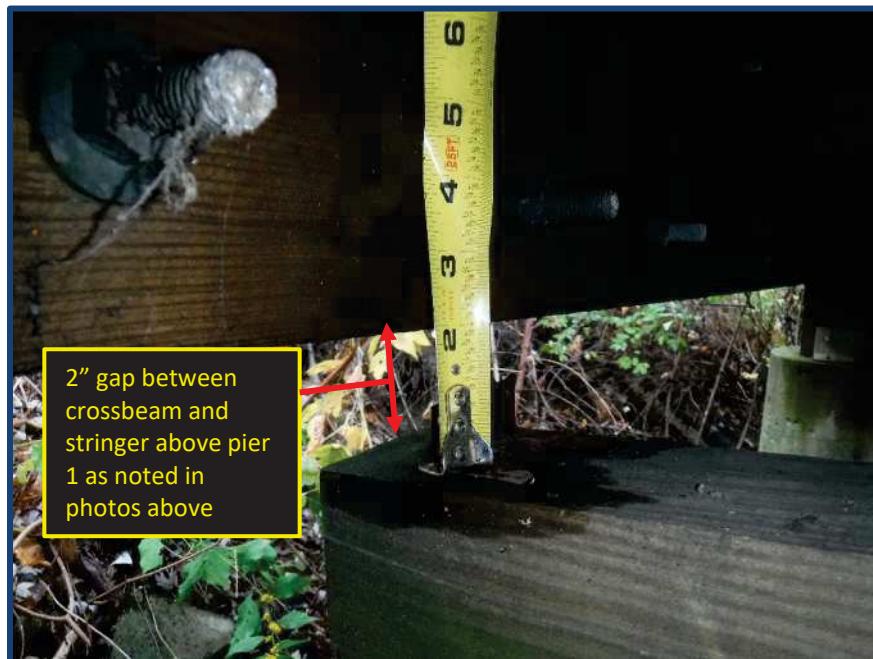
**Inspection Finding Number: 1****Photo(s):**

- Slope erosion, existing stone retaining wall failure, and vegetative growth has compromised up to 10 pier foundations in Section 2, inducing settlement of the piers. The settlement of the piers has caused a complete loss of support for the boardwalk in two locations and compromises the safety of the boardwalk in Section 2 ([Inspection Findings 1](#) through [6](#)). The piers exhibiting settlement appear to bear only on the in-situ soils and do not appear to extend to bedrock.

**Description:** Slope erosion and undermining of two concrete piers was observed at this location. The erosion appears to be due to a storm sewer outfall directly above the piers. The erosion has caused the piers to settle by an estimated 4"-6", as evidenced by out-of-level of the crossbeams and loss of contact between the stringers and crossbeam. In addition, there are large voids beneath one of the piers.

**Location:** Section 2, near north end of the observation deck

- 1) Retrofit 10 existing pier foundations in Section 2 with micropiles to address observed settlement and mitigate the potential for future settlement (Inspection Findings 1-6).
- 2) Repair the existing slope in the area of section 2, utilizing soil nails and shotcrete (Inspection

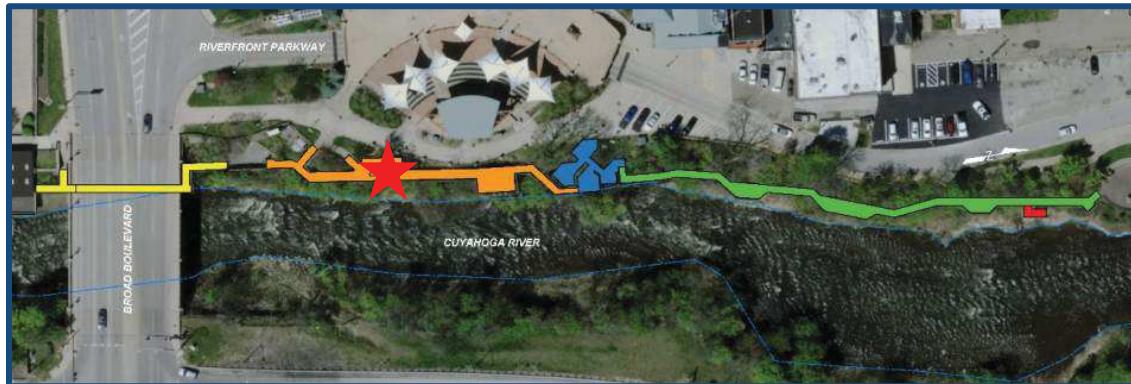
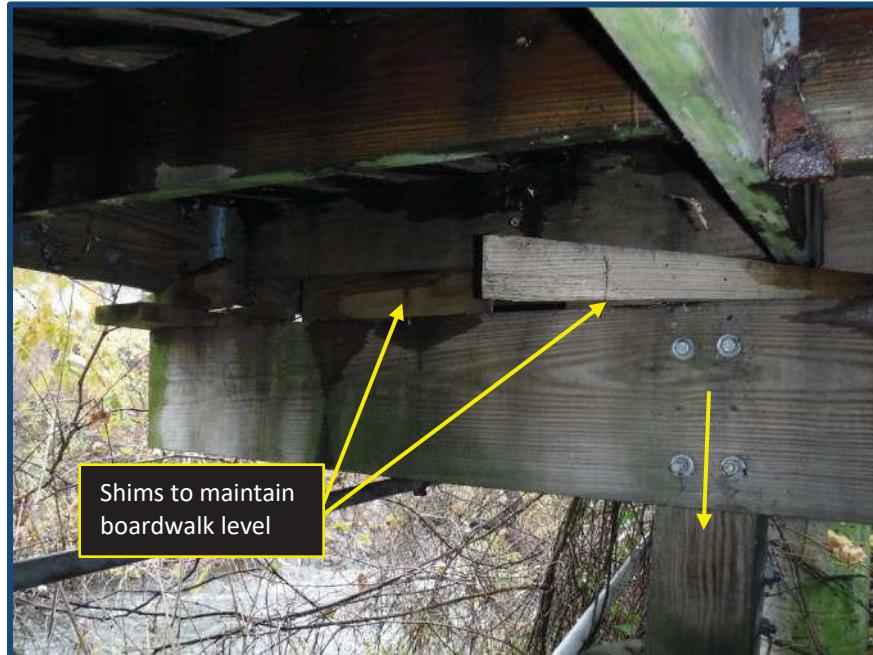
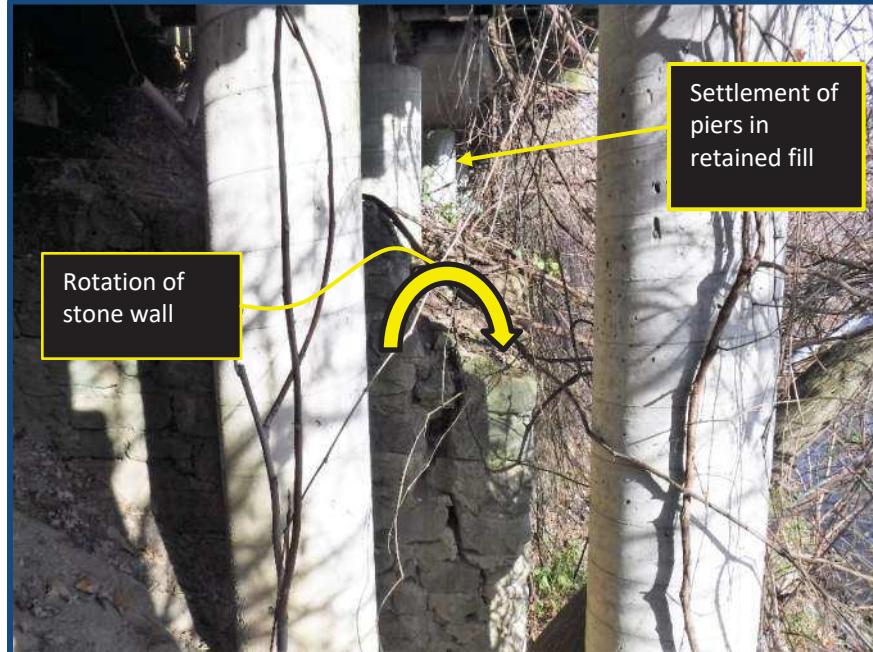
**Inspection Finding Number: 2**

- Rotation of existing stone retaining walls has caused the walls to contact piers in Section 2, introducing unintended lateral loading on the piers ([Inspection Findings 2](#) and [7](#)).

**Description:** Slope erosion and subsidence, and rotation and partial failure of an existing stone wall retaining fill was observed. The retained fill appears to support five piers which in turn support the east portion of the observation deck. The observed subsidence and erosion of the fill has caused settlement of the four north most piers, as evidenced by shimming required to maintain the deck in a level position. Up to approximately 3" of pier settlement has occurred at the worst location.

**Location:** Section 2, observation deck

- 3) In conjunction with item 2), stabilize existing stone walls along Section 2 (Inspection Findings 2 & 7) utilizing soil nailing and shotcrete.
- 4) Remove trees that are compromising existing pier foundations (Inspection Findings 4 & 5).
- 5) Replace cracked or rotted timber piles in Sections 4 & 5 (Inspection Finding 16).
- 6) Epoxy inject cracks at piers in Section 3 and strengthen the piers with FRP (Fiber Reinforced Polymer) wrap (Inspection Finding 14).
- 7) Replace cracked bracing in Section 3 (Inspection Finding 15).

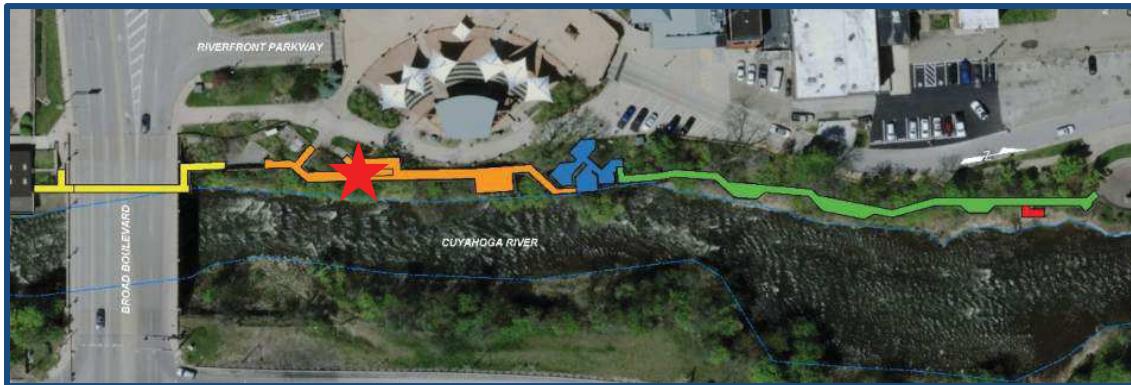
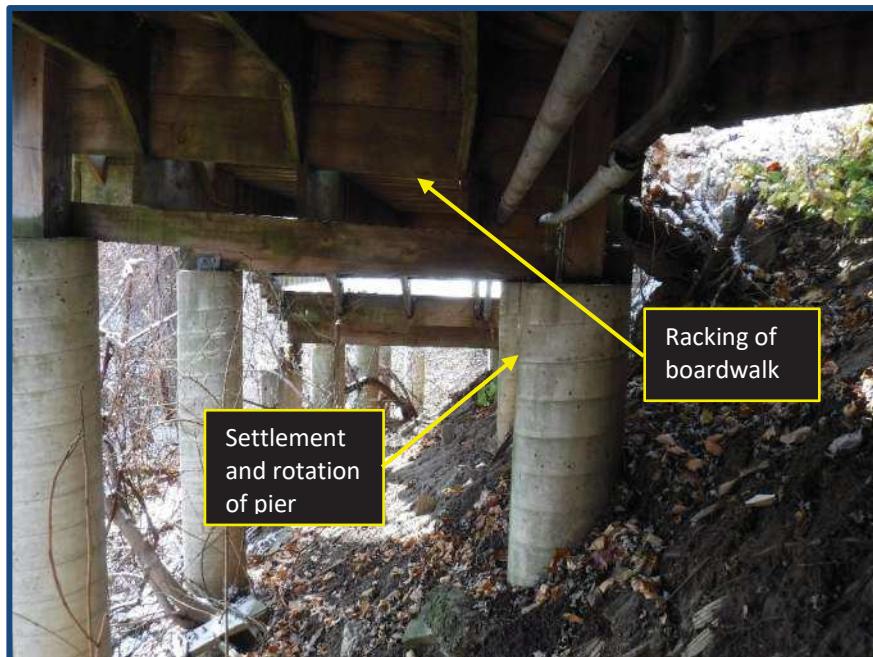
**Inspection Finding Number: 3**

**Description:** Settlement of a concrete pier was observed, as evidenced by racking of the boardwalk structure.

**Location:** Section 2, base of stairs near access point 'C'

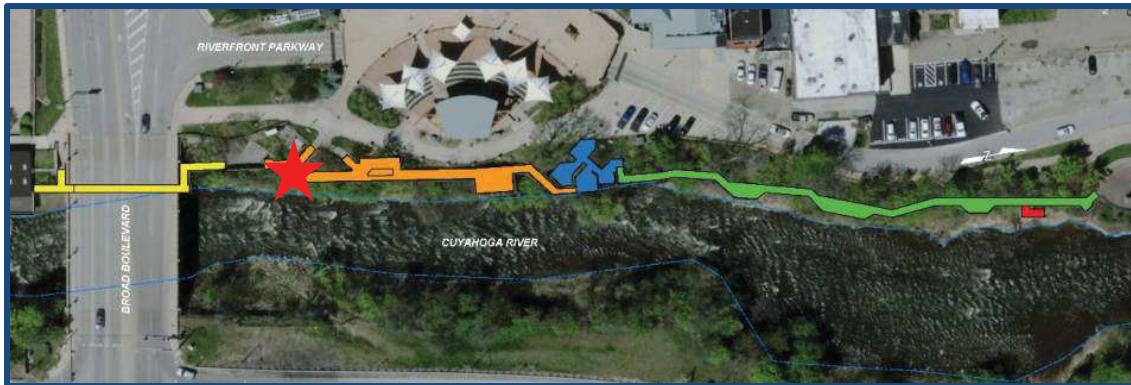
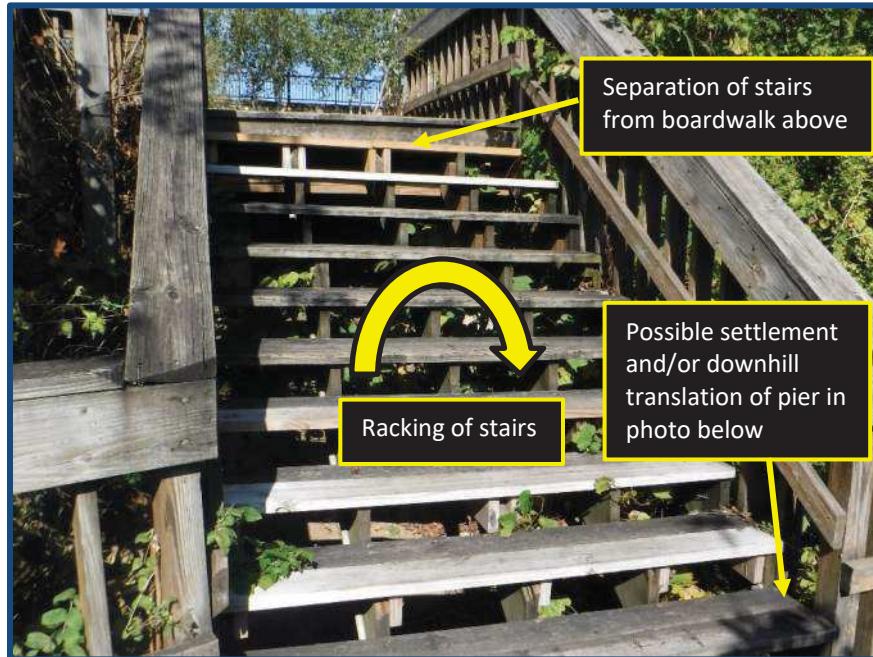
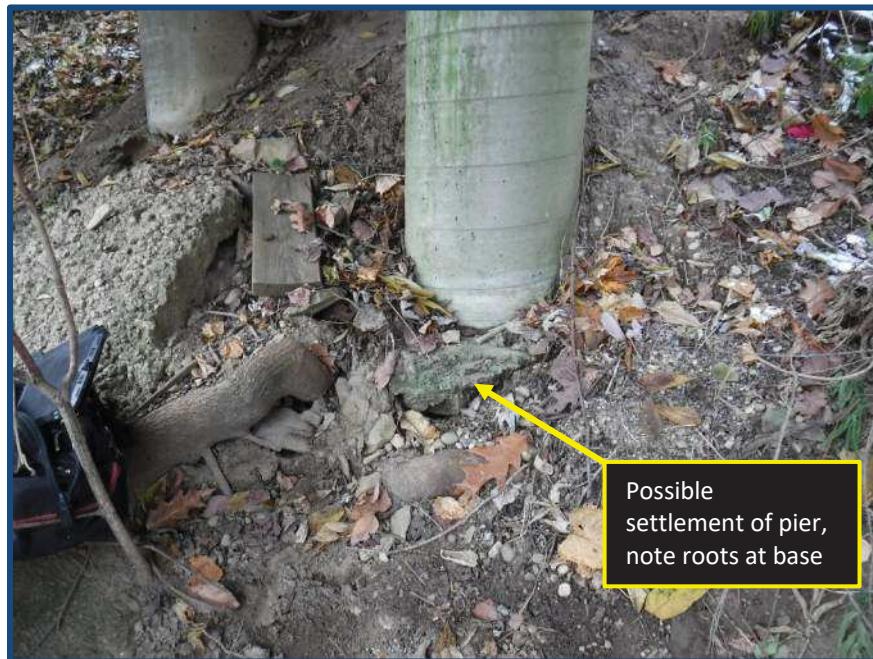
**Inspection Finding Number: 4**

**Description:** Racking of the stairs, separation of the stairs from the boardwalk, and possible settlement of the pier at the base of the stairs was noted at the location described below.

**Location:** Section 2 at the south stairway near the courtyard area.

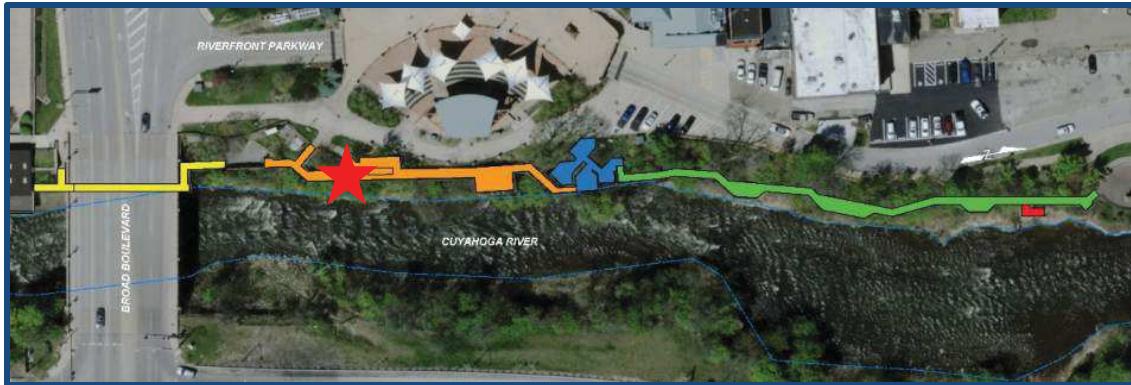
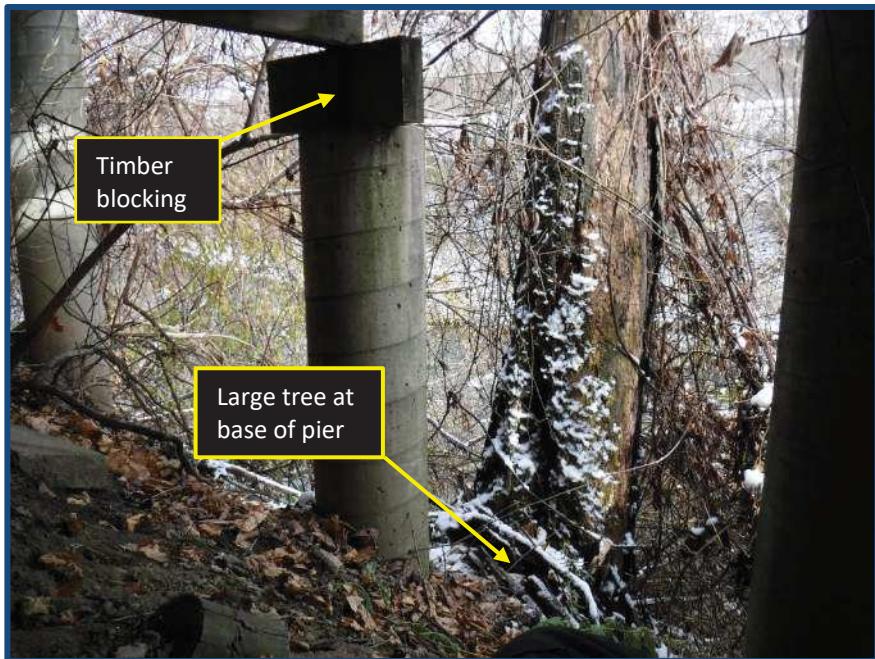
**Inspection Finding Number: 5**

**Description:** Possible settlement of a pier was noted at the location below, as evidenced by timber blocking and a large tree growing near the base of the pier.

**Location:** Section 2, just south of observation deck.

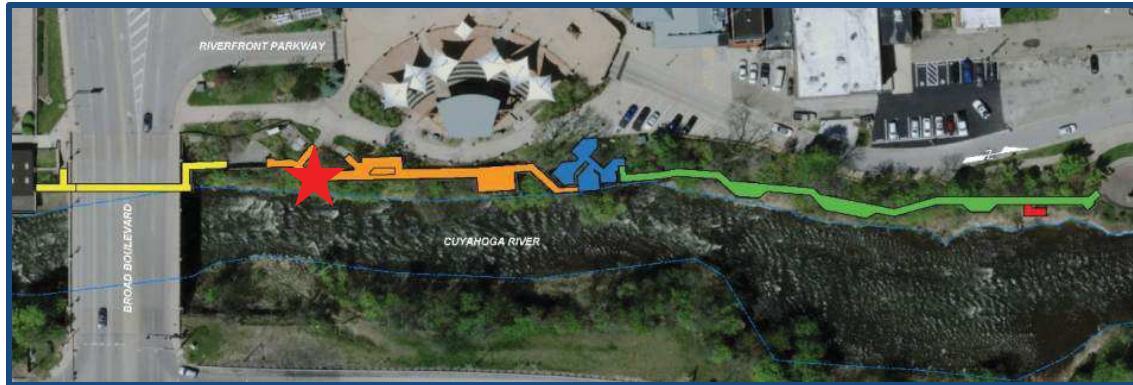
**Inspection Finding Number: 6**

**Description:** Possible settlement of two adjacent piers was noted at the location below, based on out of level crossbeams

**Location:** Section 2, near bend point in boardwalk between south stairs and observation deck.

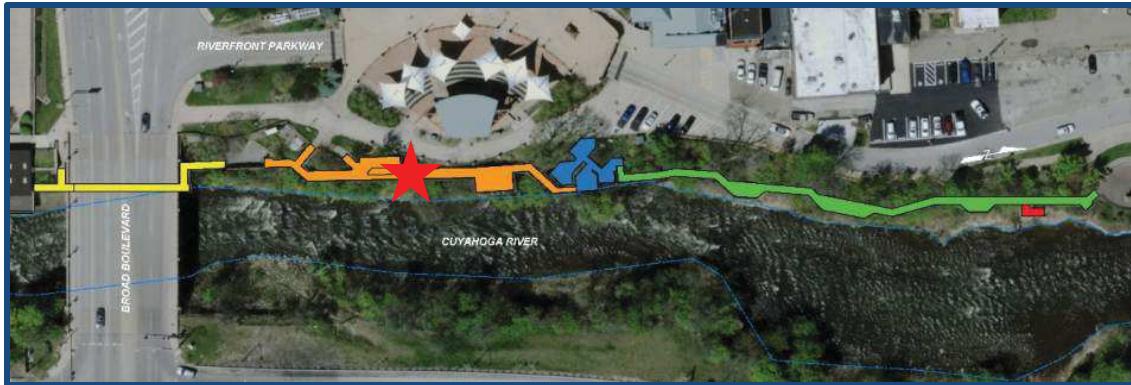
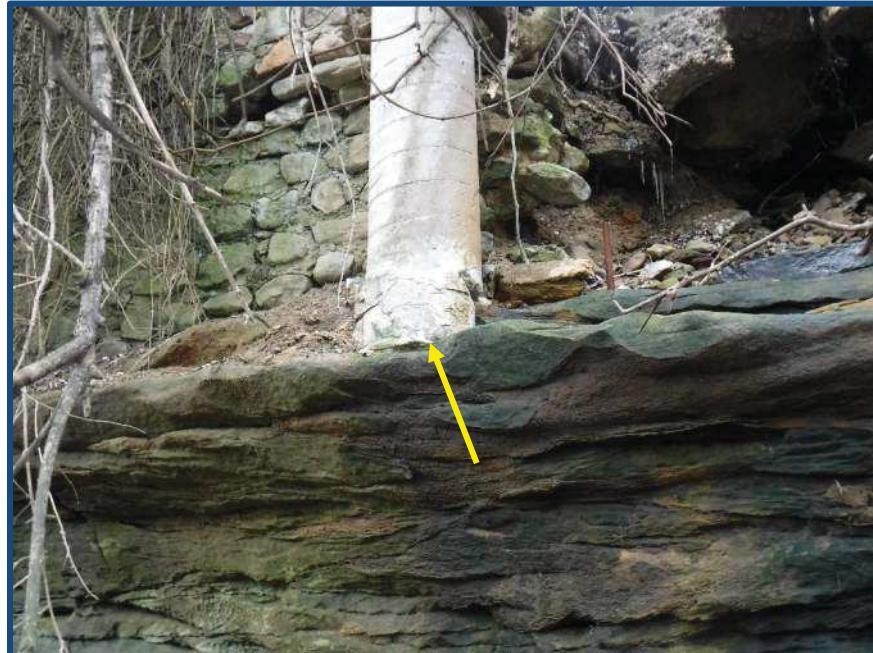
**Inspection Finding Number: 8**

- Concrete deterioration has reduced the bearing area of a pier supporting the boardwalk near the north end of the observation deck ([Inspection Finding 8](#)).

**Description:** Concrete deterioration was observed at the base of a pier in Section 2. The observed deterioration has reduced the bearing area of the pier and exposed reinforcing steel.

**Location:** Section 2, just north of observation deck.

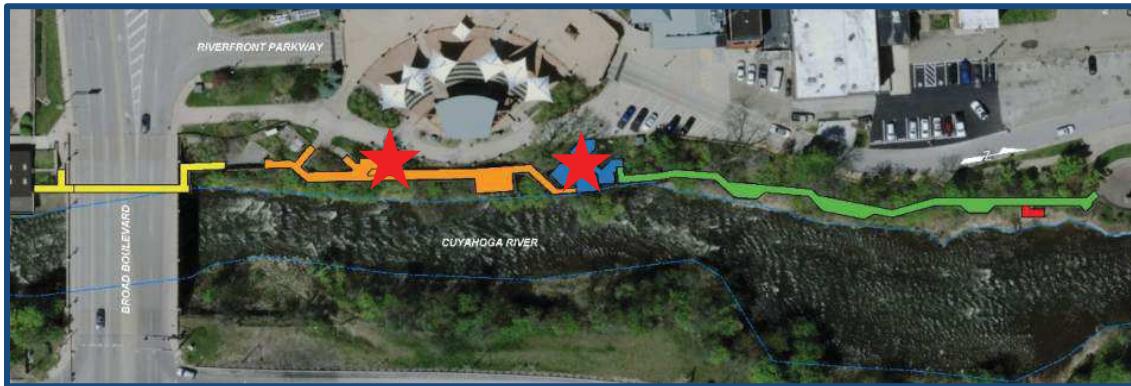
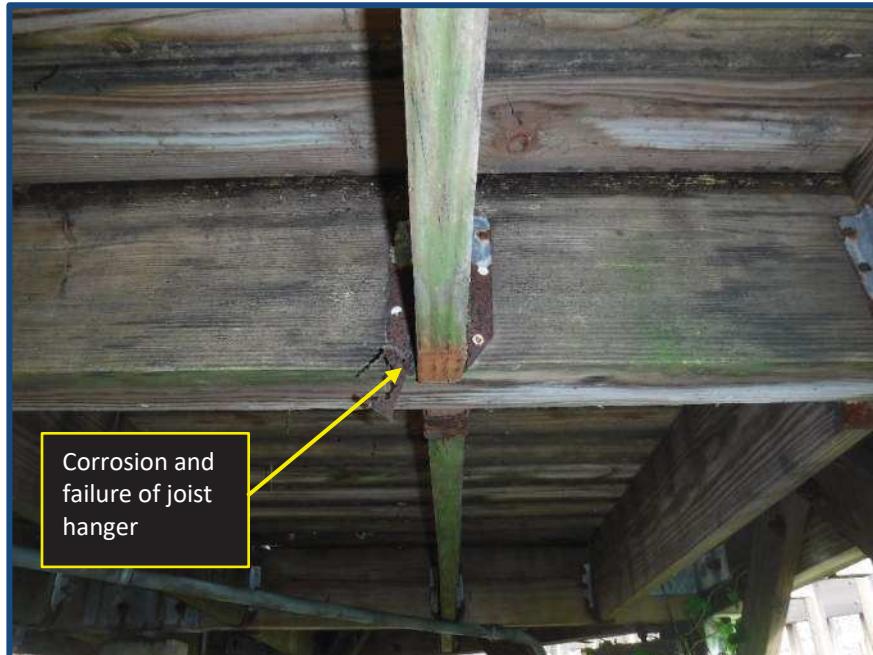
**Inspection Finding Number: 9**

- Corroded and completely failed joist hangers were noted throughout the structure, particularly in Sections 2 and 3. The failures compromise the safety of the boardwalk in Section 2 and portions of Section 3. ([Inspection Finding 9](#)).

**Description:** Corroded and completely failed joist hangers were noted in multiple locations. The locations with the highest number of failed hangers are the observation deck in Section 2 and the decks in Section 3. There were also other scattered locations throughout the structure where joist hangers are either corroded or completely failed in Section 1, Section 2, Section 3 and Section 4. The location of the hanger failures in Section 4 does not compromise the integrity of the structure in this location.

**Location:** Section 2, Section 3, and other scattered locations throughout the structure

- 8) Replace all joist hangers throughout the structure (Inspection Finding 9).
- 9) Replace selected stringers with rot or cracking (Inspection Finding 23)
- 10) Rebuild all stairs to remain with new stringers meeting current ADA standards (Inspection Finding 12).
- 11) Replace deck boards in Sections 1, 2, 3 & 4 (Inspection Finding 22).
- 12) Install supplemental anchor bolts at ledger boards attached to concrete walls at access points A and E (Inspection Finding 13).
- 13) Replace corroded through bolts in Section 4 (Inspection Finding 13).
- 14) Install new railings along the length of the boardwalk meeting current Ohio Building Code standards.
- 15) Install ADA compliant hand rails at all ramps and stairs.

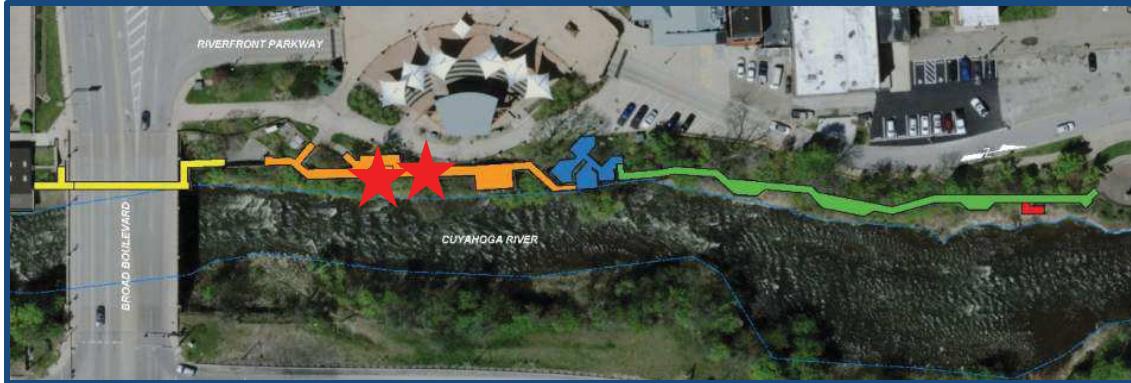
**Inspection Finding Number: 10**

- Deterioration of existing stone walls in Section 2 has compromised the stability of the walls and the uphill slopes retained by the walls ([Inspection Finding 10](#)).

**Description:** Existing stone walls along Section 2 exhibit varying degrees of deterioration. The deterioration is compromising the stability of the walls and the uphill slopes retained by the walls. Also reference inspection findings 2 and 7.

**Location:** Section 2 and Section 3

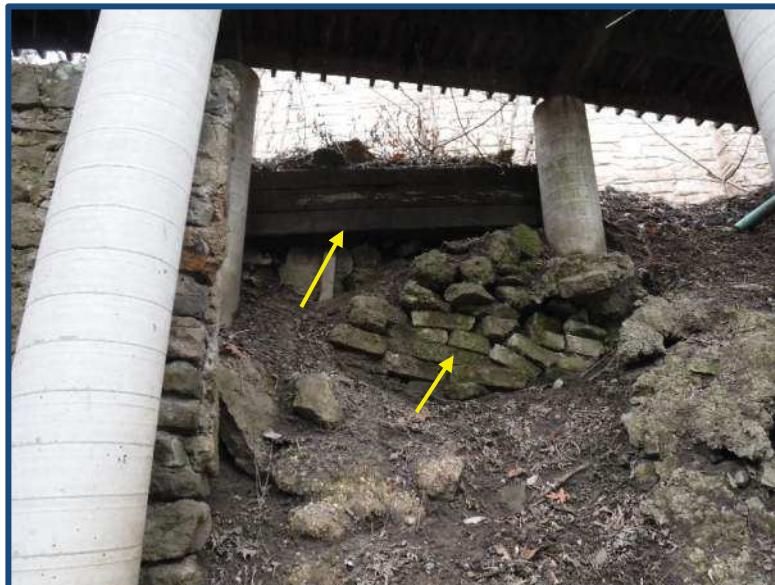
- Timber railroad ties and concrete blocks appear to have been used to address slope erosion at the base of a pier column in Section 2. No discernable settlement was observed at this pier ([Inspection Finding 11](#)).

**Description:** Timber railroad ties and concrete blocks appear to have been used to address slope erosion at a pier column in Section 2. No discernable settlement was observed at this pier.

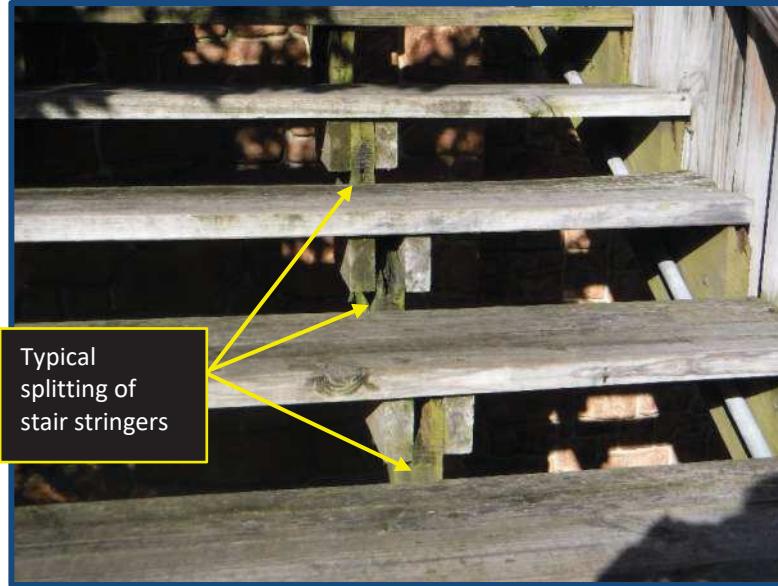
**Inspection Finding Number: 12**

- The stair stringers throughout the structure typically exhibit cracking and checking near the connection of the front tread to the stringer, leading to loose stair treads ([Inspection Finding 12](#)).

**Description:** The stair stringers throughout the structure typically exhibit cracking and checking near the connection of the front tread to the stringer. Numerous scab repairs have been completed to re-secure the stair treads to the stringers.

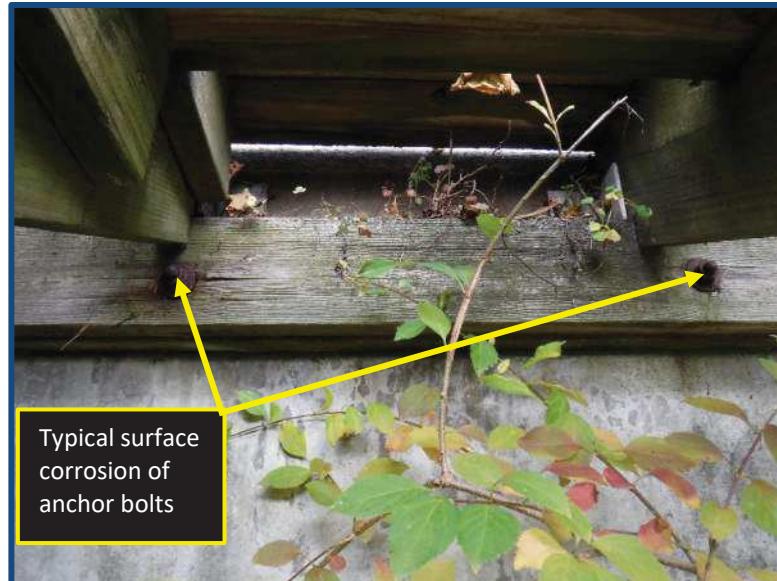
**Description:** Anchor bolts and fasteners throughout the structure exhibit varying degrees of surface corrosion. The stainless steel bolts and fasteners used in Sections 1 and 2 remain in good condition.

Typical surface corrosion of anchor bolts

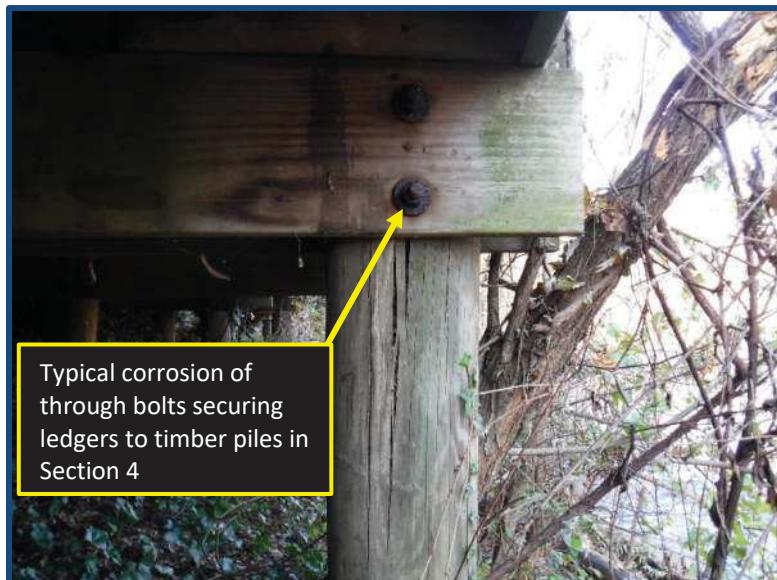
Typical corrosion of through bolts securing ledgers to timber piles in Section 4

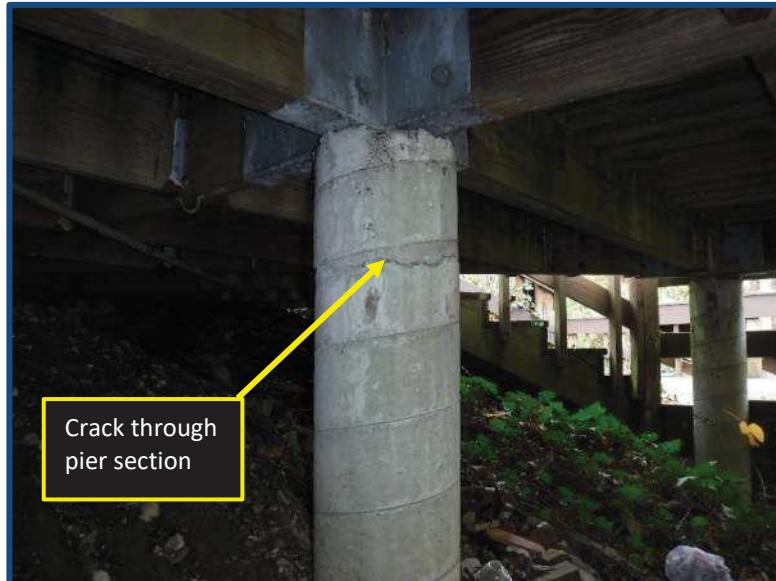
**Inspection Finding Number: 14**

**Description:** In Section 3, 4 concrete piers are cracked through the entire section.

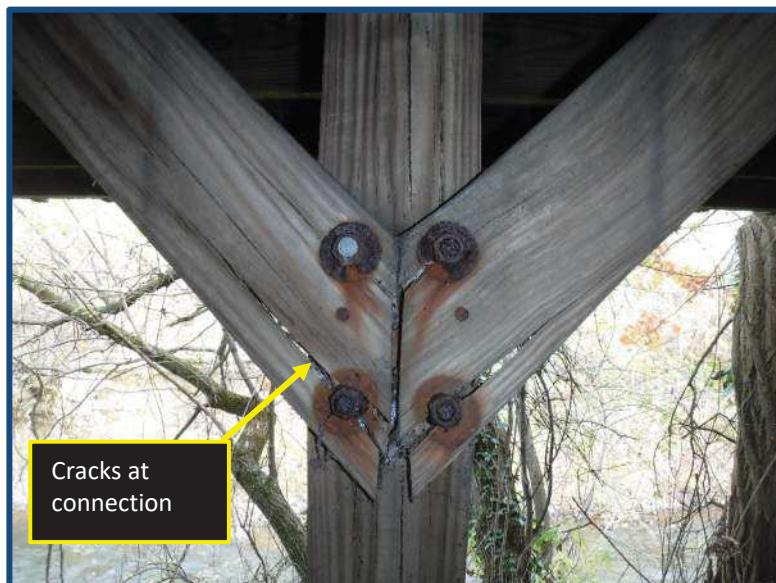
**Inspection Finding Number: 15**

**Description:** In Section 3, 9 braces are cracked at the connection point.

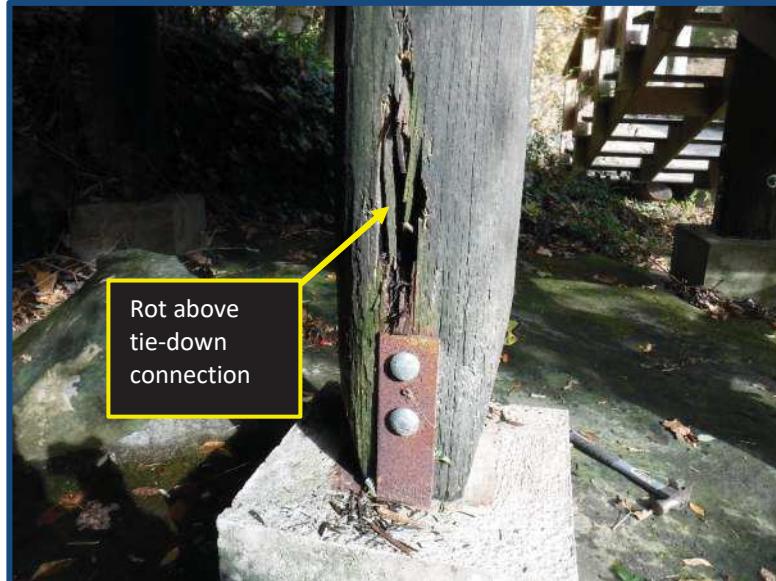
**Inspection Finding Number: 16**

**Description:** In Section 5, rot was observed at 4 timber piles above the tie-down connection.

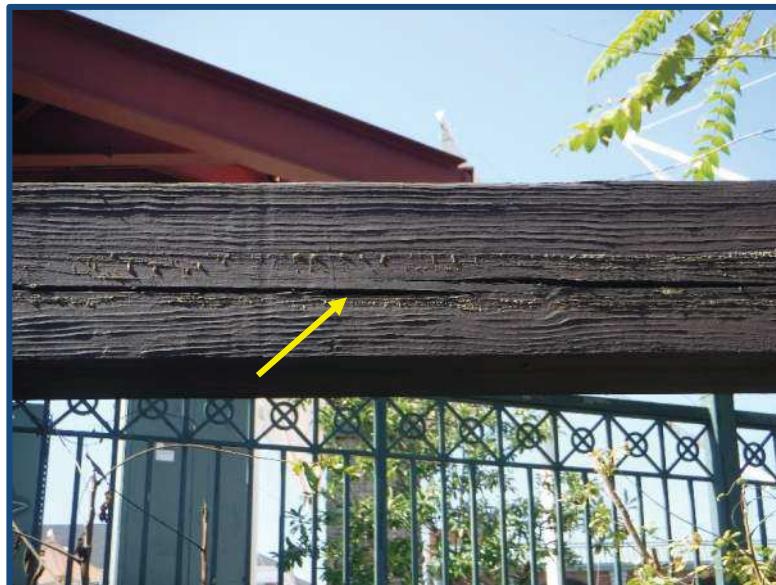
**Inspection Finding Number: 17**

**Description:** Splits up to 3" deep were noted in Section 2 on the pavilion structure roof framing members.

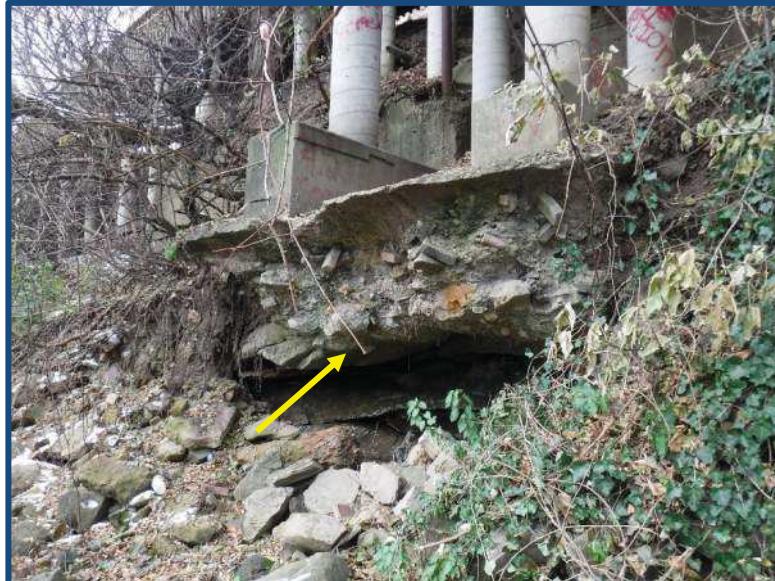
**Inspection Finding Number: 18**

**Description:** Undermining of the stream bank and pavilion structure footings was observed. The fill in this area consists of a large amount of building rubble cemented together.

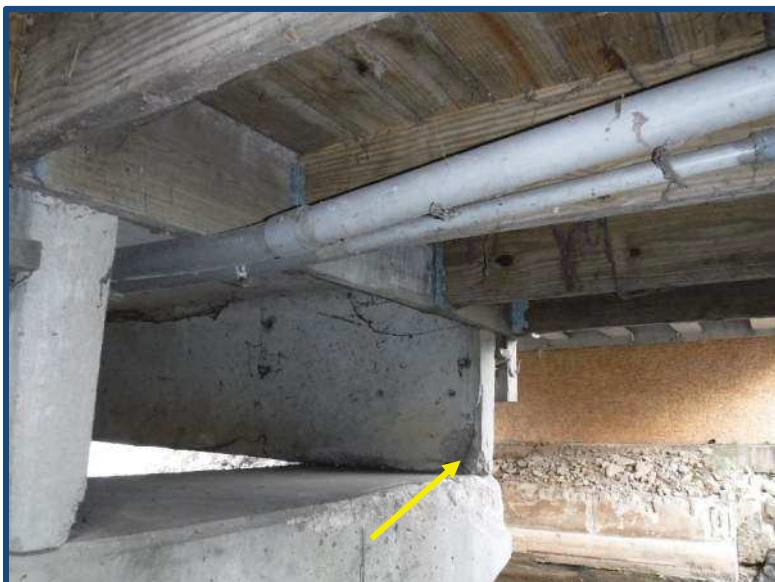
**Inspection Finding Number: 19**

**Description:** Spalling of concrete was observed at the precast double tee stems in Section 1.

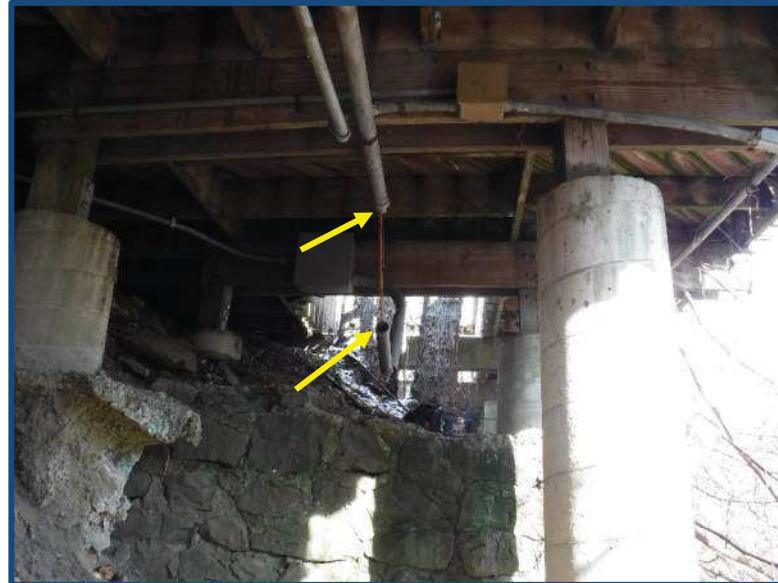
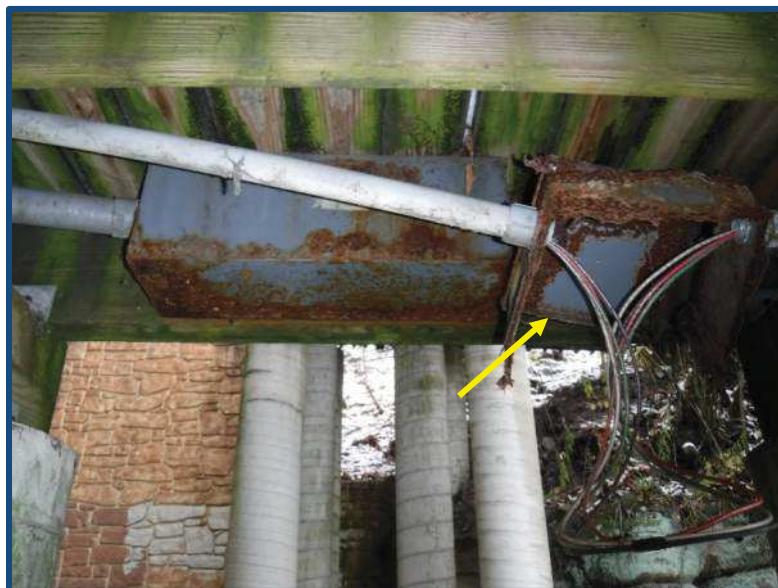
**Inspection Finding Number: 20**

**Description:** Broken electrical conduit and corroded pole boxes for the boardwalk lighting were noted throughout the structure.

- 16) Repair conduit, pull boxes, and wiring for lighting and security cameras throughout the structure.

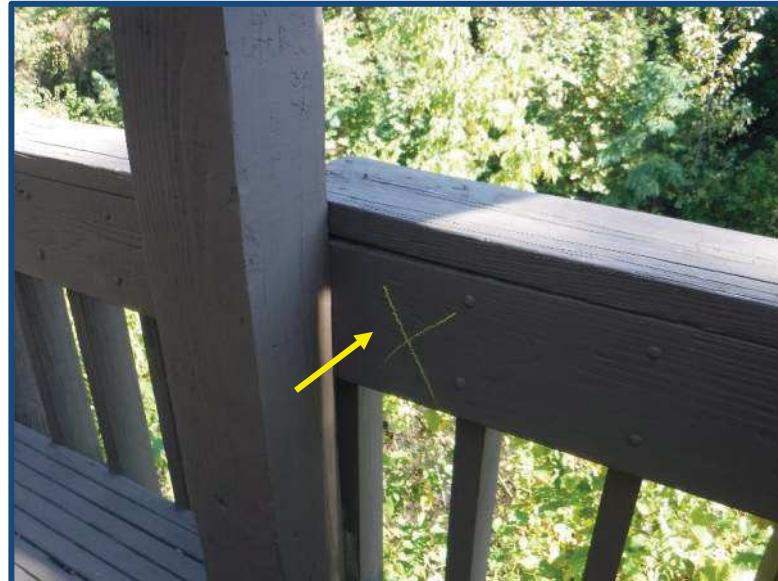
**Inspection Finding Number: 21****Description:** Loose railing connections were noted at various locations**Photos:**

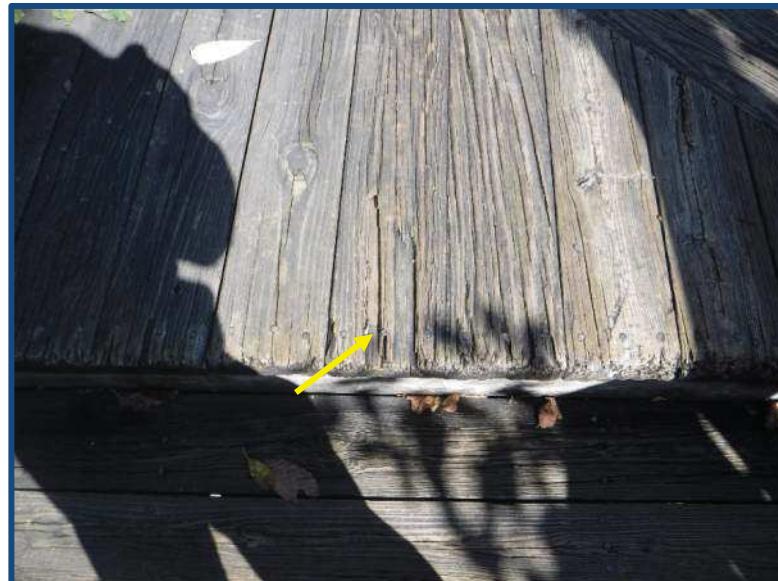
**Inspection Finding Number: 22****Description:** The deck and railing boards in Sections 1, 2, 3 & 4 are highly weathered and aged in places.**Photos:**

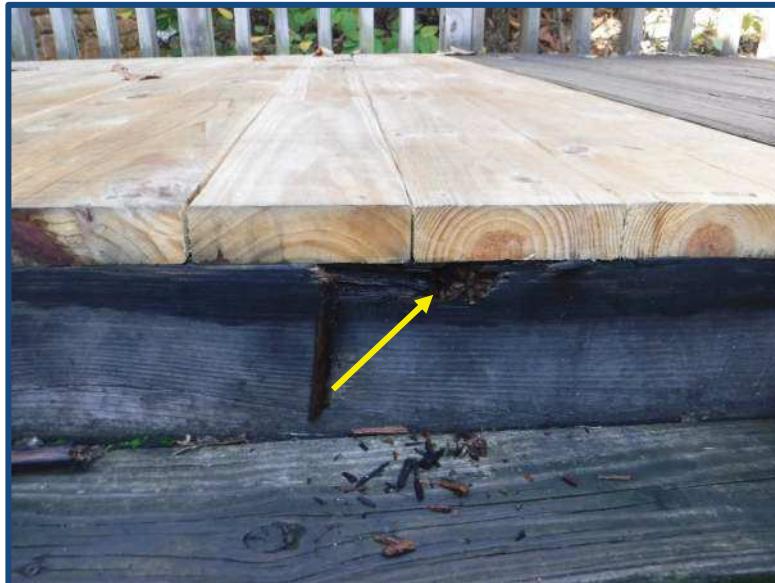
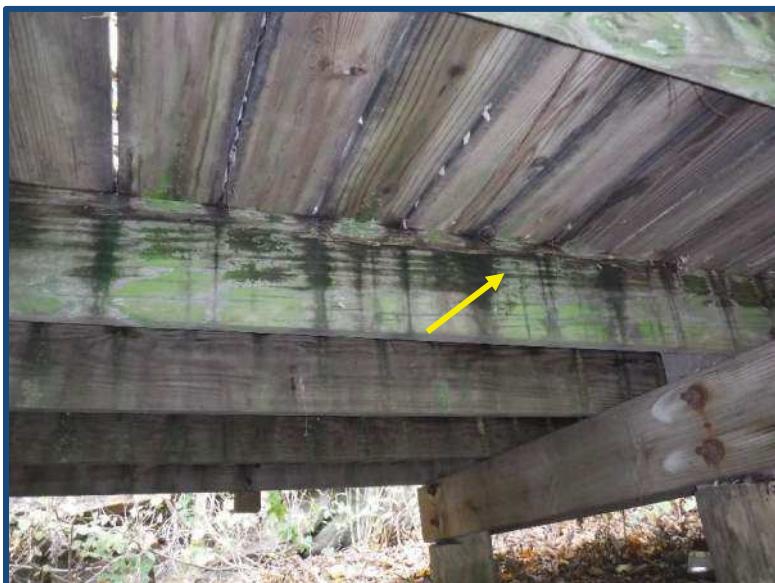
**Inspection Finding Number: 23****Description:** Isolated railing boards and floor stringers exhibit rot and/or cracking**Photos:**

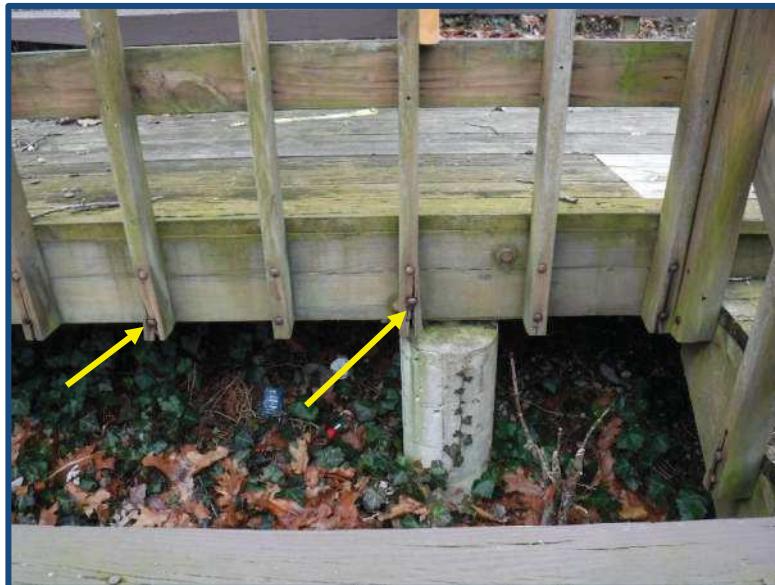
**Inspection Finding Number: 24**

**Description:** Cracked railing pickets at the anchor bolts are present at isolated locations throughout Sections 2 and 3
