Design Guidelines *for the* Cuyahoga Falls Downtown Historic District

JUNE 9, 2017

Historical
Architecture

Chambers
Murphy & Burge

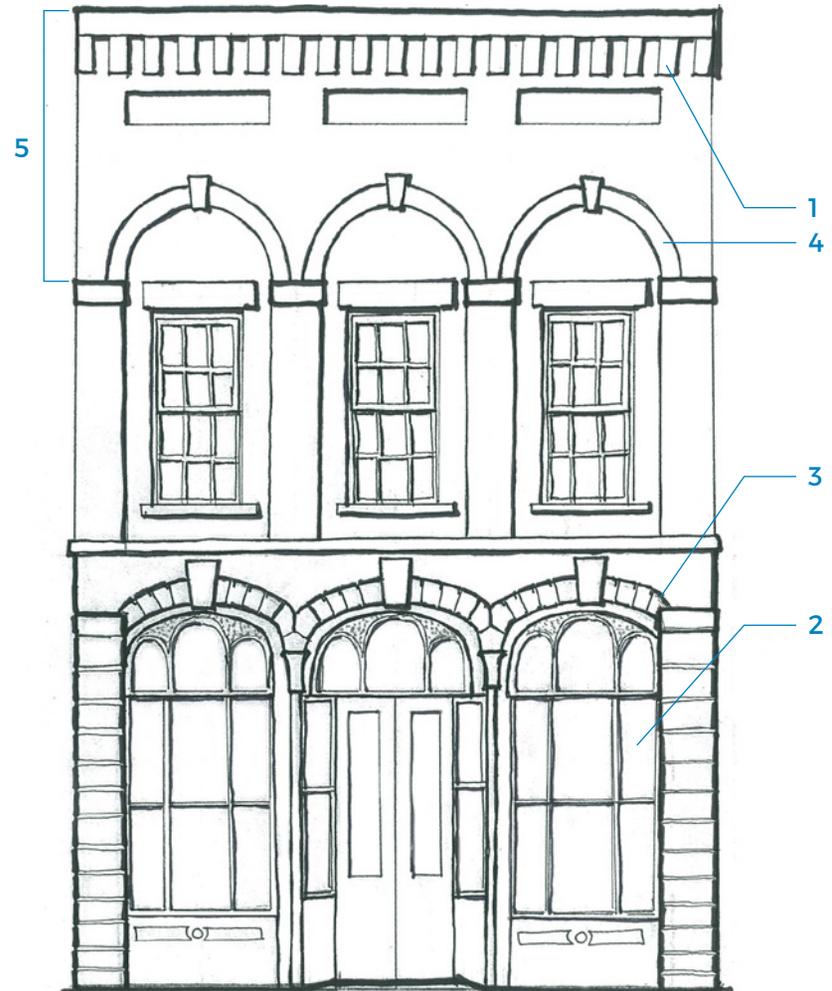
*Italianate style: commercial example.
Comstock Building, 2091 Front Street, 1874*

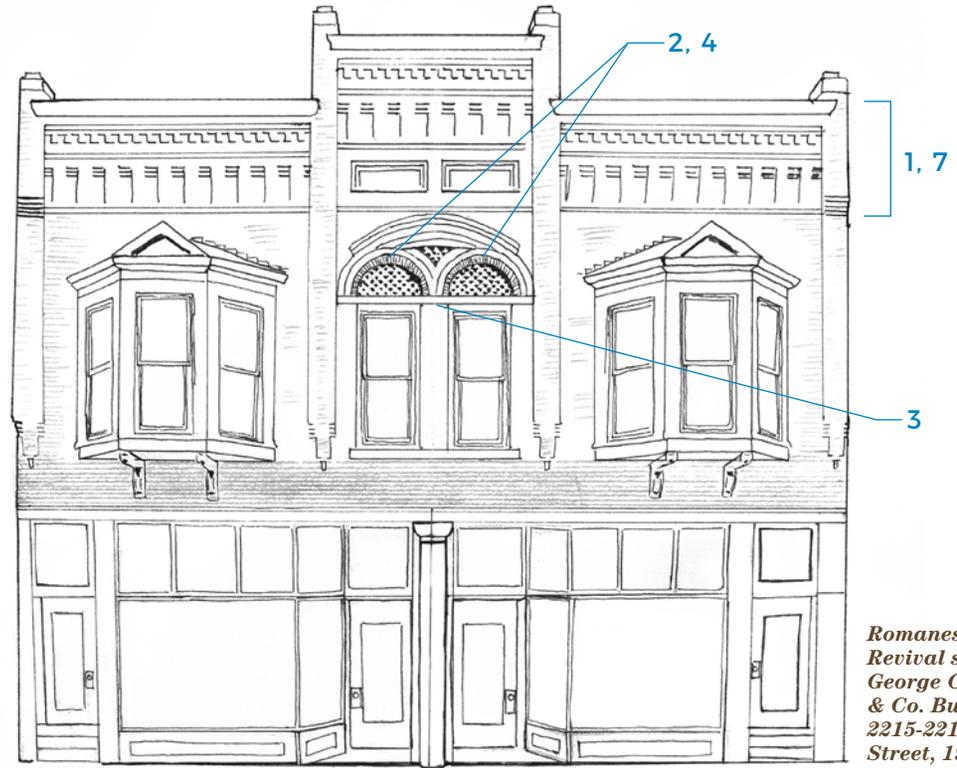
Romanesque Revival style. George C. Tiff & Co. Building, 2215-2219 Front Street, 1908.

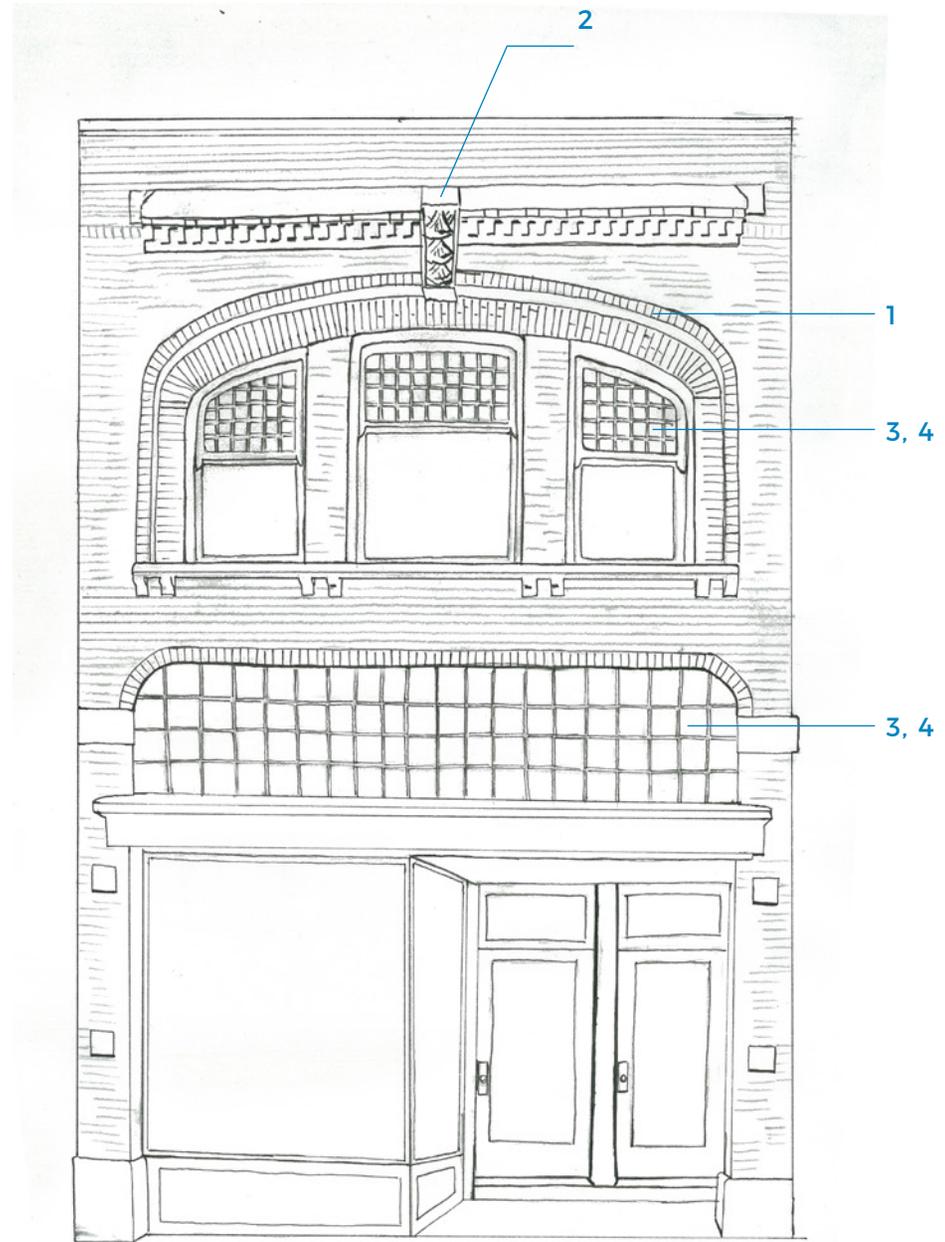
Art Nouveau Style. Falls Laundry Building, 2164 & 2166 Front Street, 1910.

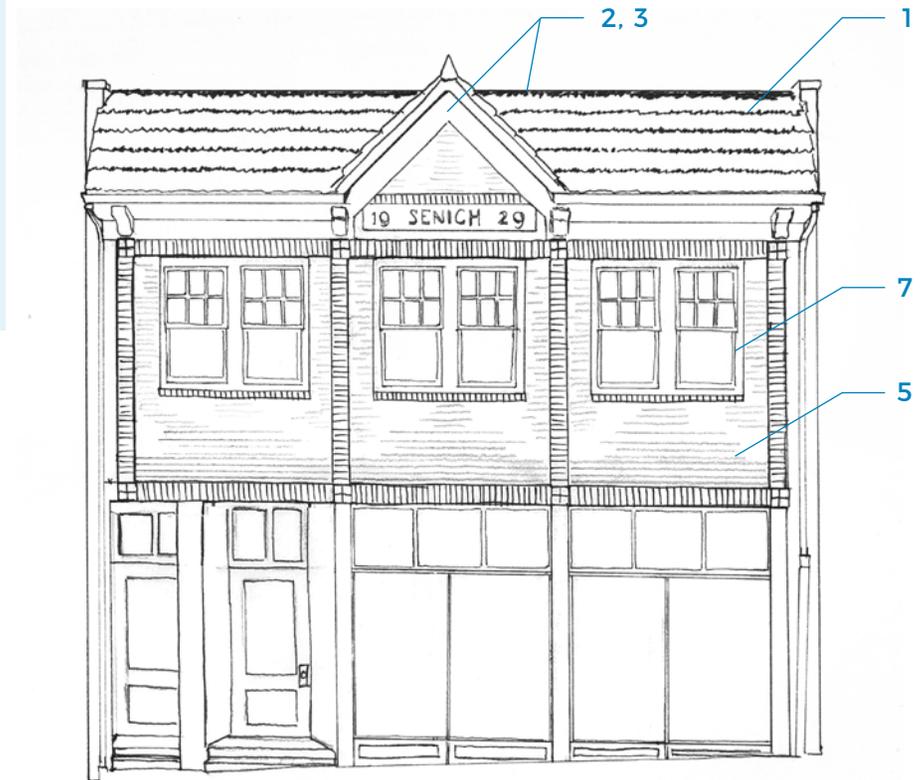
Tudor Revival style. Senich Building, 120 Portage Trail, 1929.

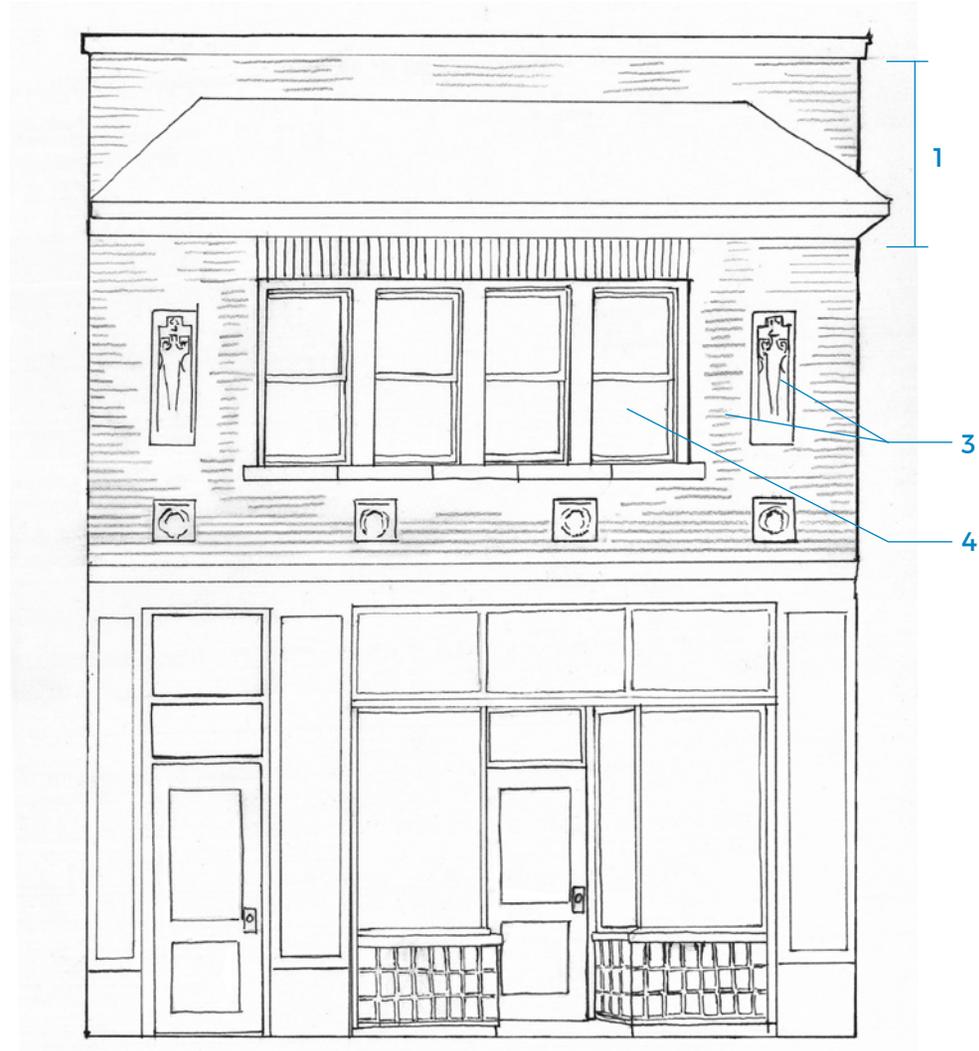
Jacobean/Jacobethan Revival style. 331-333 Portage Trail Building, 1929.

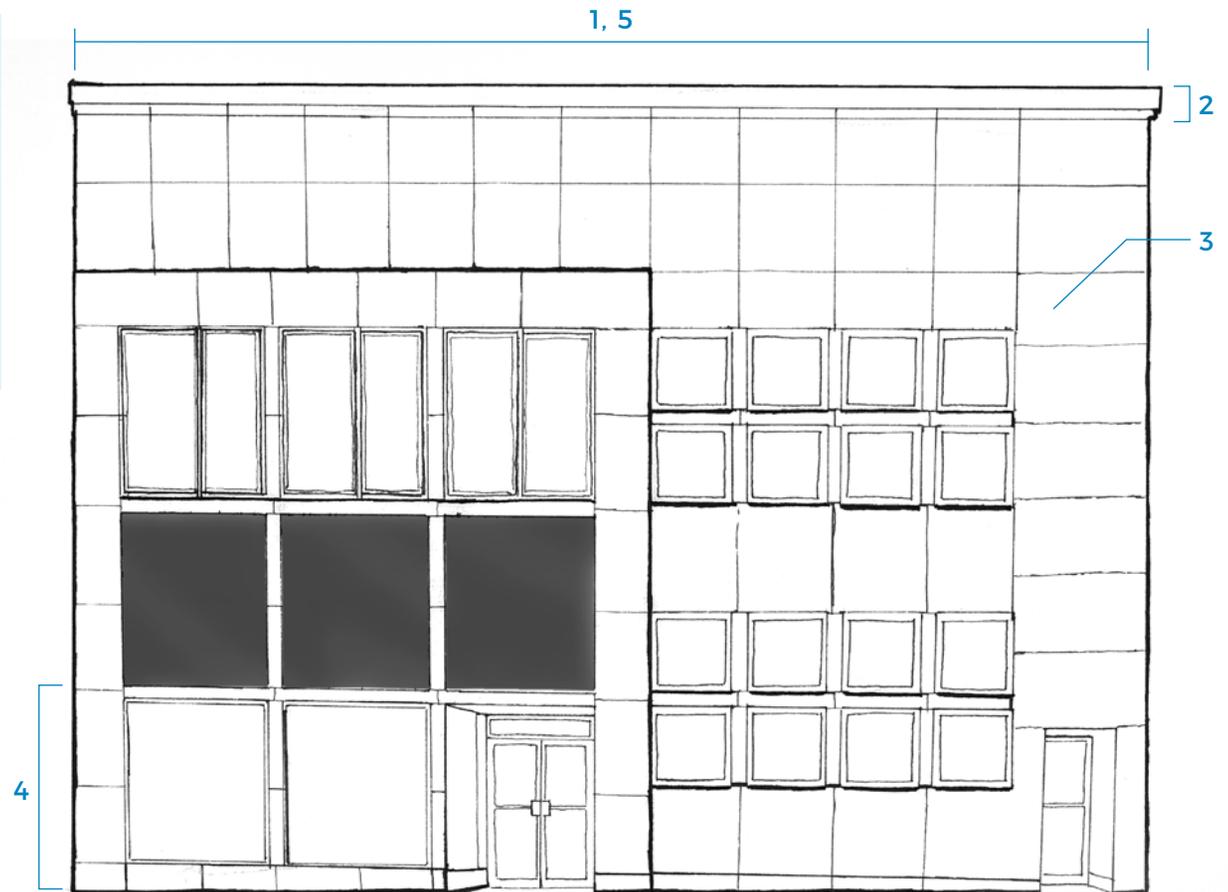
International style. Falls Savings and Loan Association Building, 2140 Front Street, 1949 alteration of a 1919 Building.

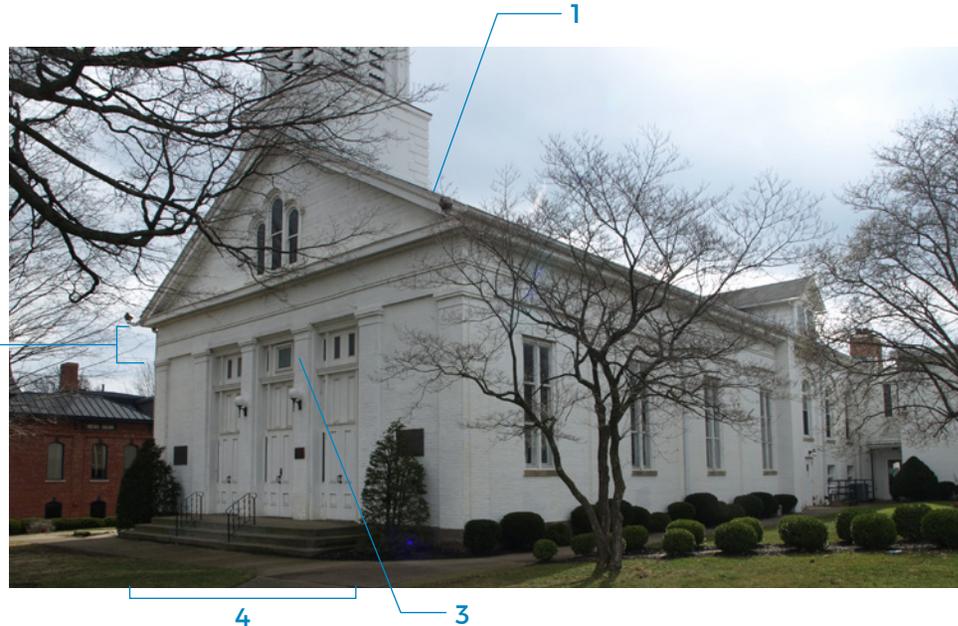
*Greek Revival style.
Pilgrim Church, 130
Broad Blvd., 1847,
NR #75001538.*

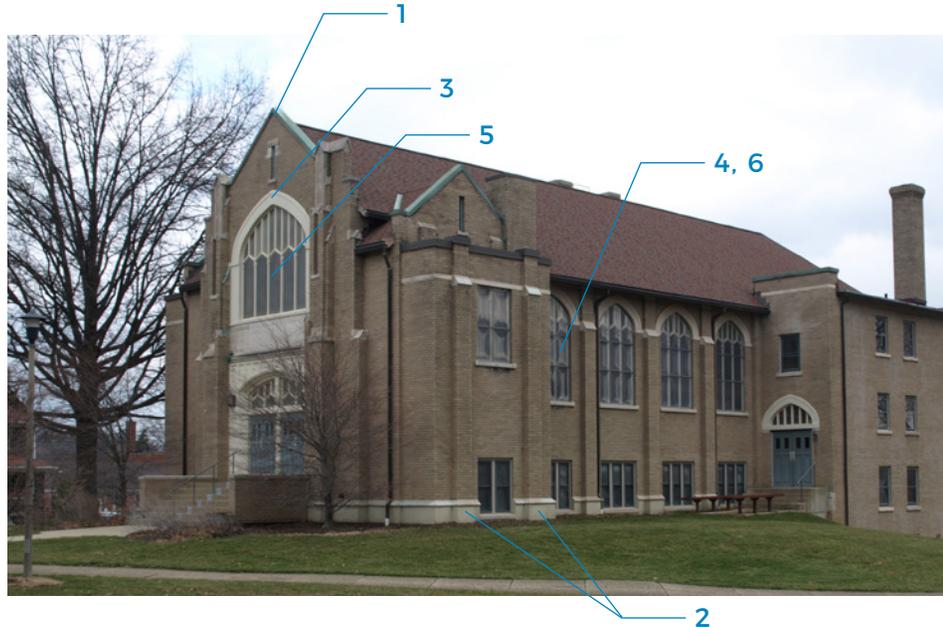
Late Gothic Revival style. First Christian Church (Disciples of Christ) of Cuyahoga Falls, 2249, 2253 3rd Street, 1929-1930.

The Gothic Revival style and Late Gothic Revival style, such as that of First Christian Church, provided an alternative to the Greek and Neoclassical Revival styles, looking to English and Norman medieval times for inspiration. This style became idealized and romanticized during the late-19th century and is characterized by pointed arched windows, stone tracery, gabled roofs and stained glass.

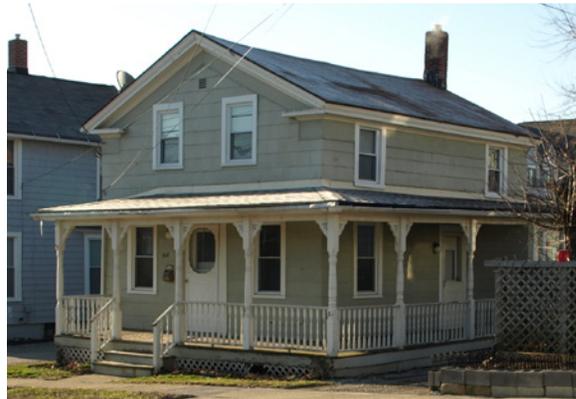
126 Falls Avenue, Greek Revival style with later porch addition.

Greek Revival's roof is emphasized with a classical entablature, which is made up of a cornice, frieze and architrave. The example is a 1-1/2 story structure with a low slope roof. At some point a porch was added and detailing reflects Queen Anne influences. See "Institutional Typology" for a discussion of the development of Greek Revival style. Colors include light earth tones (yellow, tans and grays).

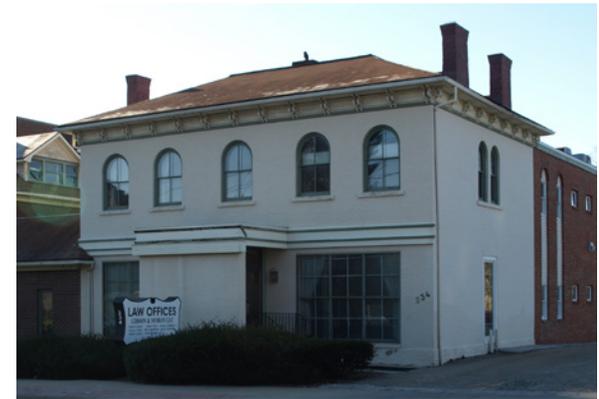
The Italianate style of the C. Henry Plum House, 234 Portage Trail, 1834 is retained at the second story and cornice.

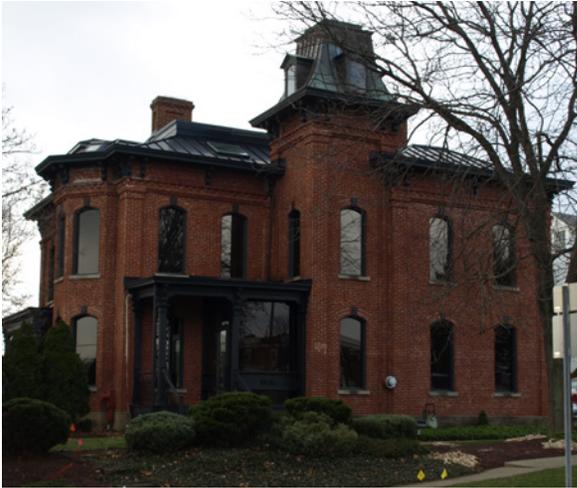
The James A. Vaughn House, 122 Broad Blvd., showcases the mature Italianate style. Alterations include a later enclosed porch and replacement windows.

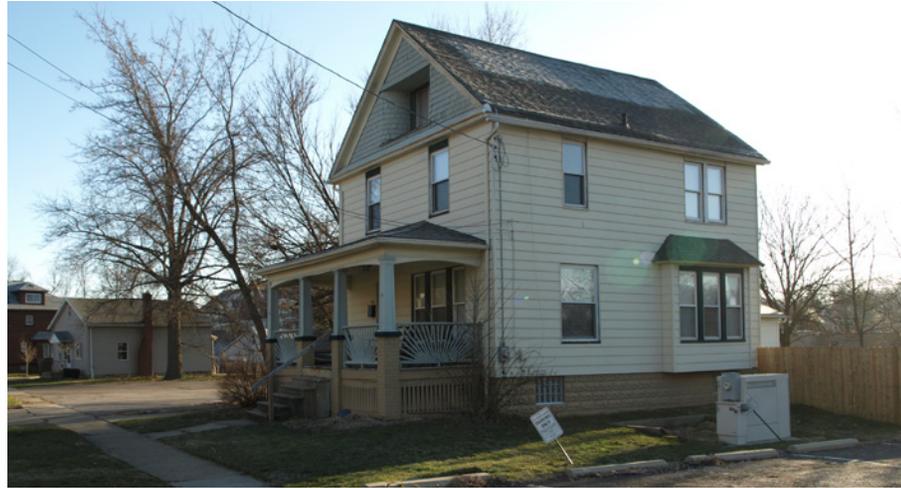
1811 2nd Street, Transition between Queen Anne and Craftsman styles.

Four decorative detailing types are common on a Queen Anne style building: spindlework at porches; classical columns; half-timbering at upper stories; and patterned masonry. Colors for both Queen Anne and Craftsman styles cover a broad range, with dark greens, reds and rusts, as well as lighter colors such as gray and white.

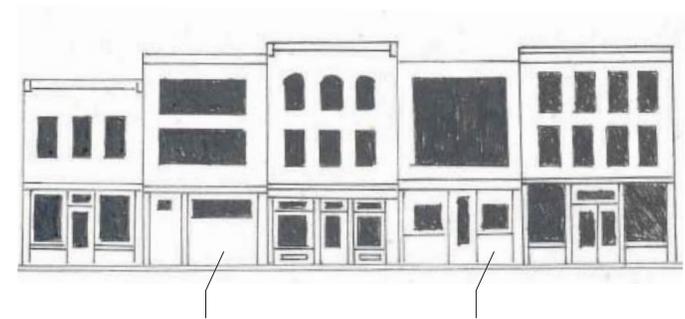
Inappropriate solid/void relationship to existing structures

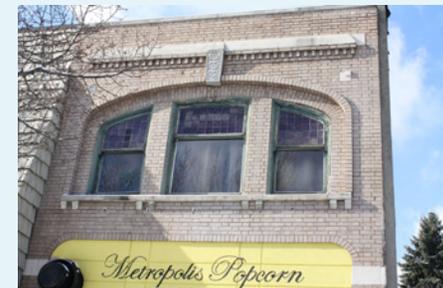
These unique second floor windows in historic Cuyahoga Falls feature original arched wood windows and stained glass in the transoms, 2164-2166 Front Street.

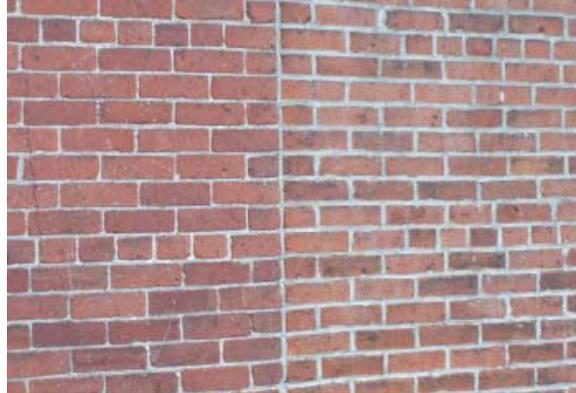
Exterior brick wall that has been built in two different time periods.

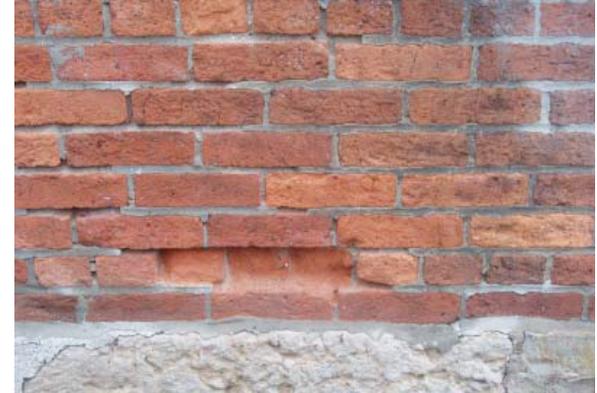
Exterior brick wall that has spalling due to water infiltration and improper repairs.

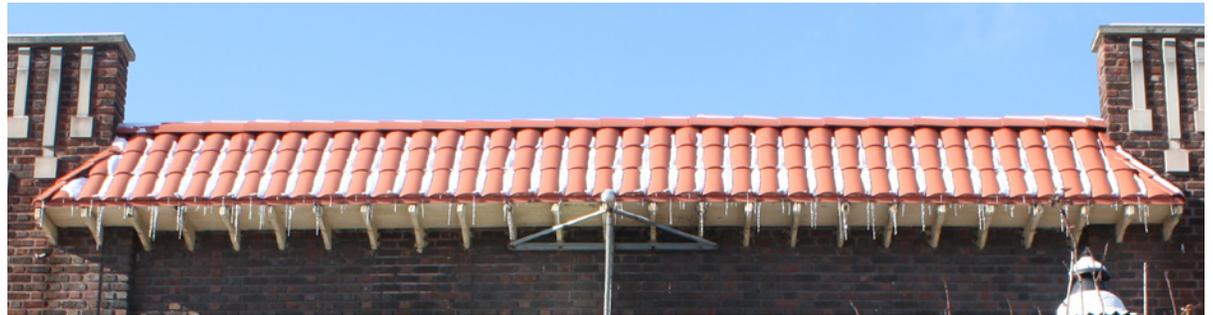
Historic tile roofing in historic Cuyahoga Falls, 2218-2220 Front Street.

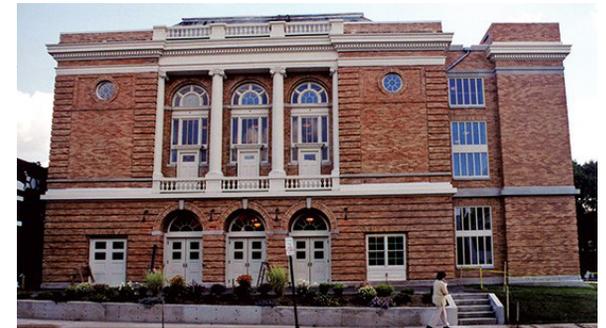
Courtesy of Preservation Brief 14 (National Park Service): A vacant side lot was the only place a new stair tower could be built when this 1903 theater was rehabilitated as a performing arts center. Constructed with matching materials, the stair tower is set back with a recessed connector and, despite its prominent location, it is clearly subordinate and differentiated from the historic theater.

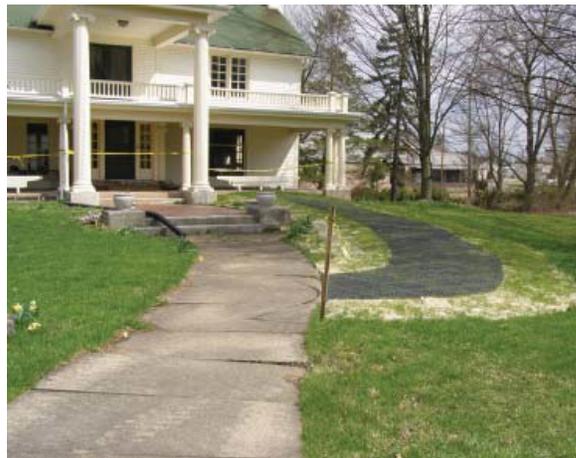
Grass pavers create a ramp without concrete and without altering the historic entrance to the building.

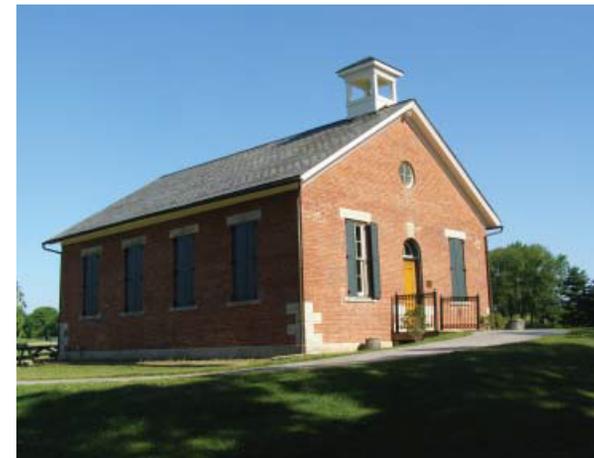
Land was graded and a sloped sidewalk installed to create a gentle ramp that makes the building accessible without destroying the appearance.

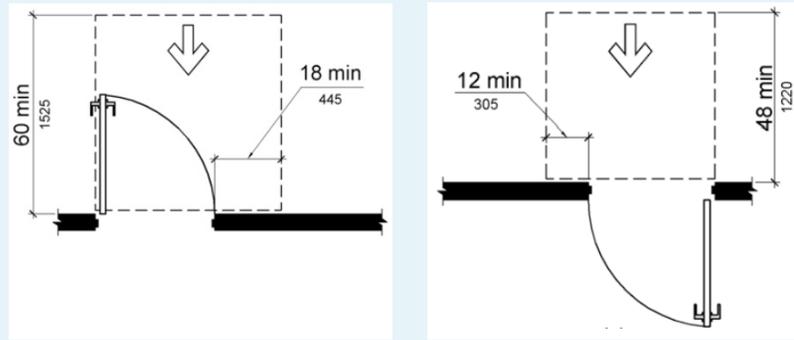
Front Approach Door Swing : Out

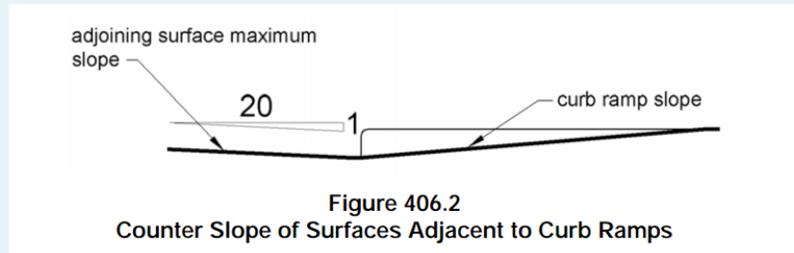
Figure 406.2
Counter Slope of Surfaces Adjacent to Curb Ramps

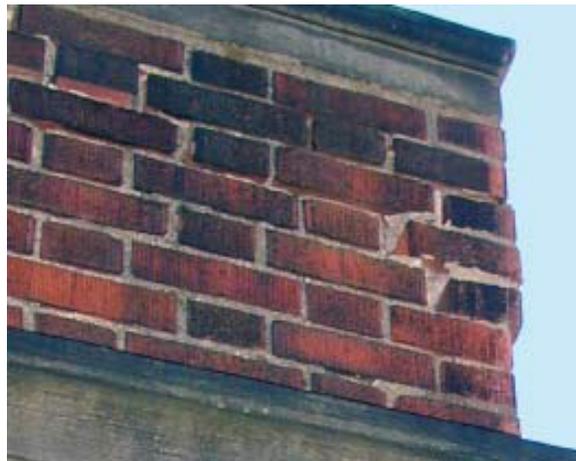
Displacement of brick by movement in the parapet wall.

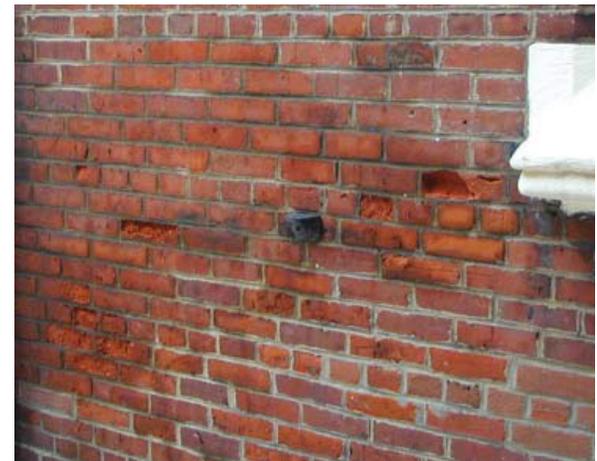
Deterioration of brick caused by moisture is marked by discoloration and brick erosion.

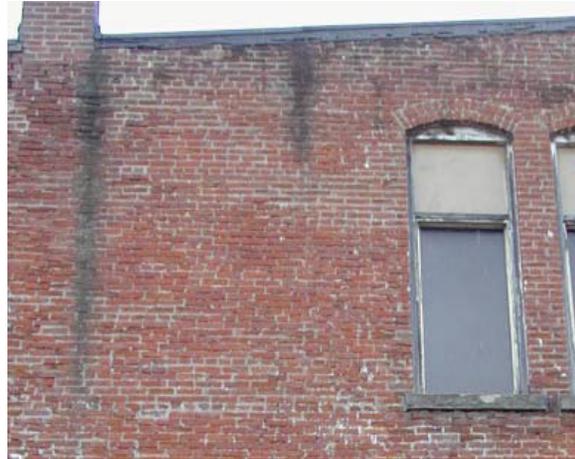
Dirt and stains on brick caused by runoff from the roof and corroded metal coping.

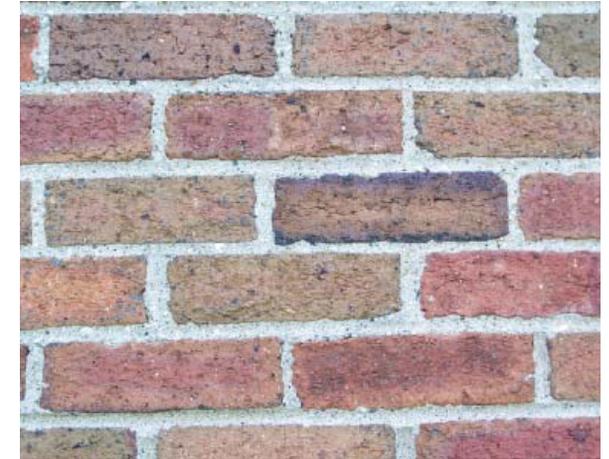
Damage to brick caused by sandblasting.

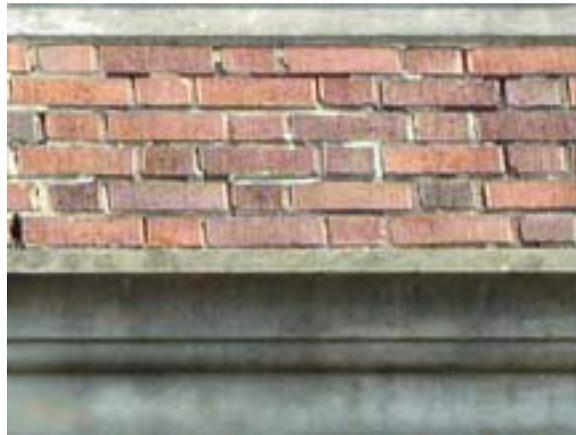
Deteriorating mortar and open mortar joints in a masonry wall.

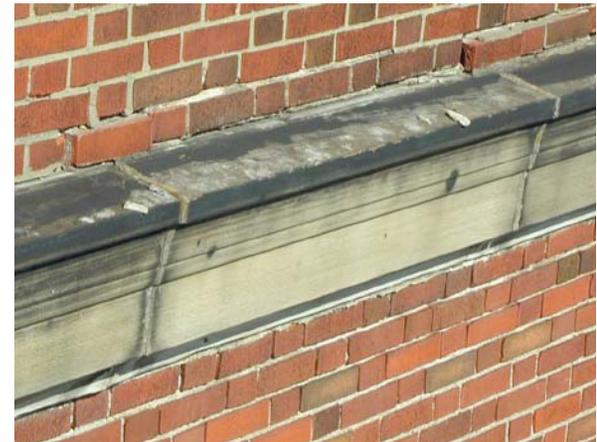
Loose brick falling out of wall due to poor conditions of mortar joints (moisture and movement in masonry system).

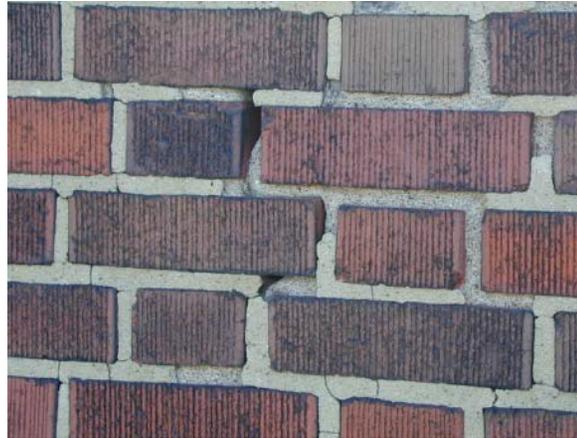
Previous poor repointing. Repointing mortar is falling out of joint due to improper execution.

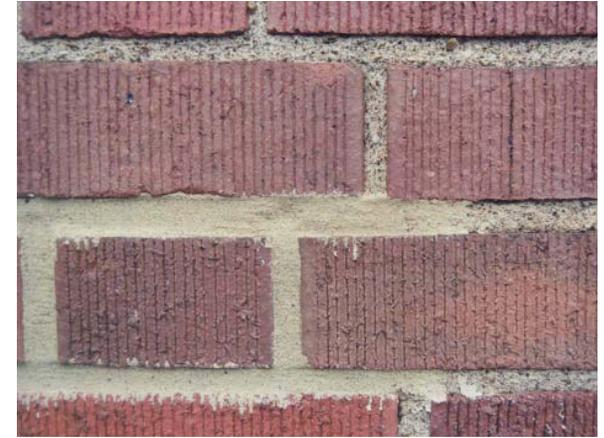
Recent poor repointing. New mortar is on face of brick and does not match original mortar in color, texture or tooling.

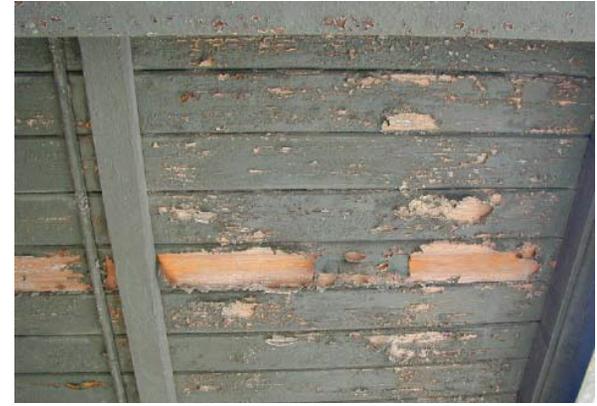
Paint failure on the underside of a wood canopy.

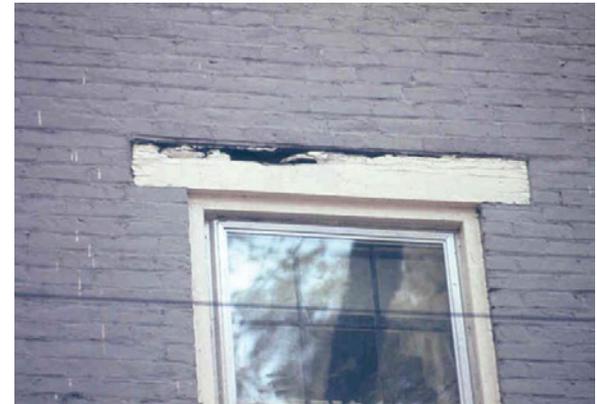
Rot caused by fungi feasting on wood window lintel.

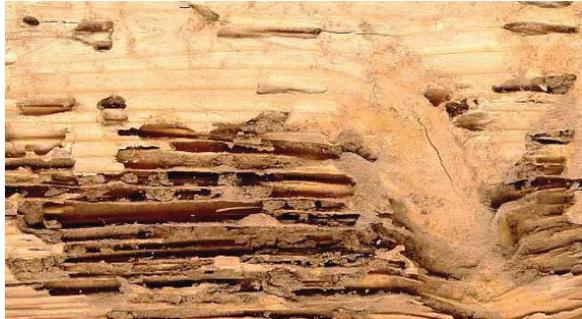
Galleries and debris in a wood floor joist indicate insect infestation.

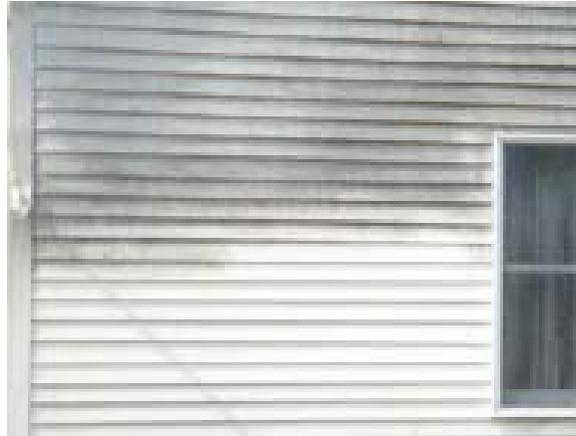
Mildew on painted exterior siding.

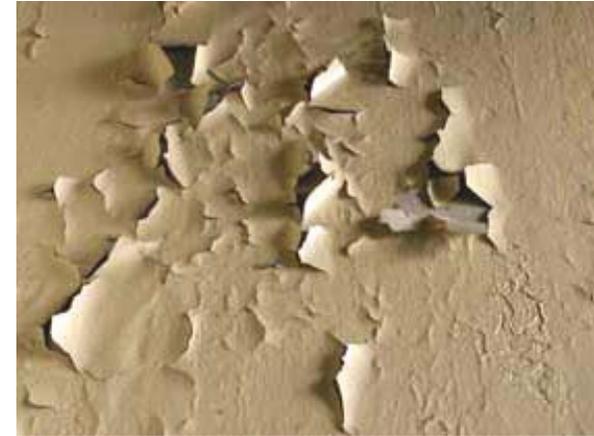
Peeling paint on interior wall.

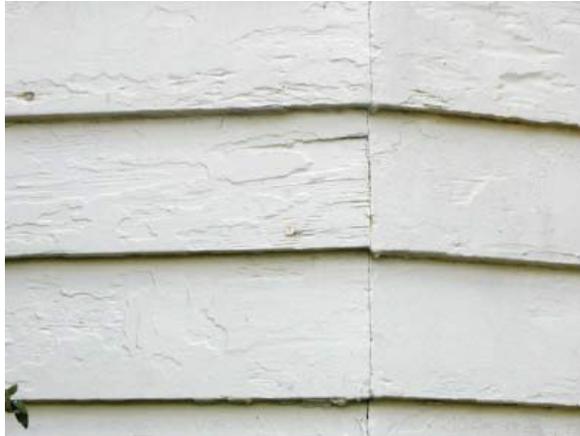
Improper preparation before applying paint results in a poor finish.

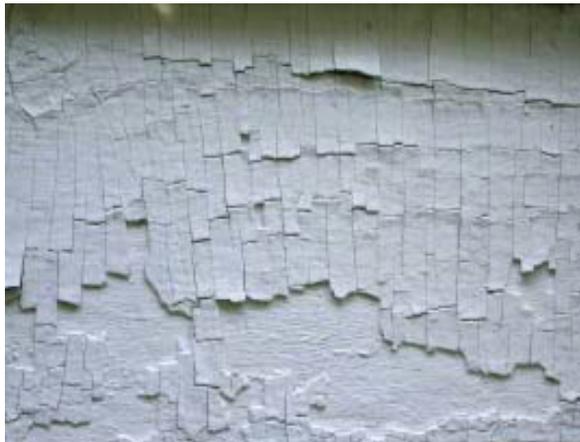
Alligatoring paint on exterior siding.

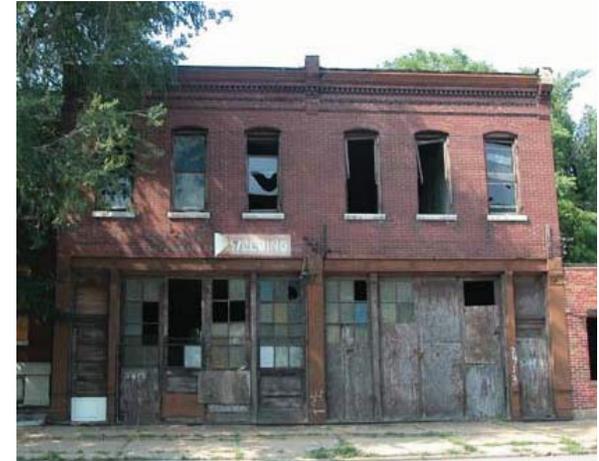
Lack of minimum maintenance over an extended period may render a building beyond rehabilitation.

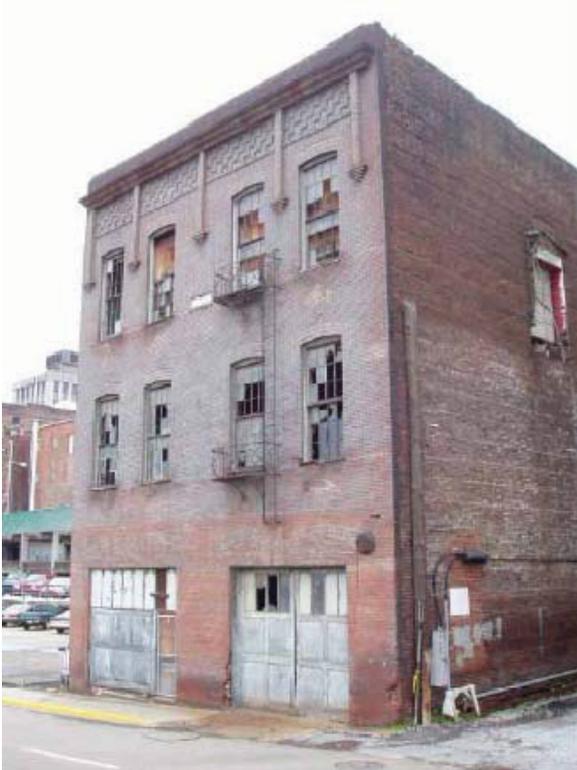
This structure has been neglected and is not dry or safe.
