Station 3 Evaluation

GBC DESIGN, INC.
ARCHITECTURE AND ENGINEERING

GBC Project No. 47216

**CUYAHOGA FALLS
FIRE STATION NO. 3**
SUMMARY ASSESSMENT
1601 PORTAGE TRAIL
CUYAHOGA FALLS, OHIO 44221

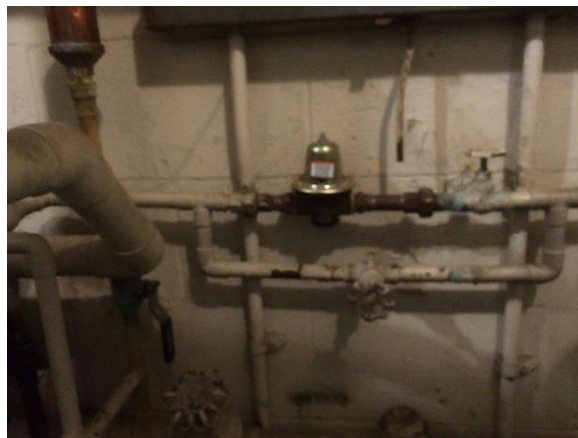
Plumb Pic 3

- The cold water supply to the boiler does not have a backflow preventer. See Plumb pic 3.
- The building is supplied domestic cold and hot water through copper pipes routed under the concrete floor to the fixtures.

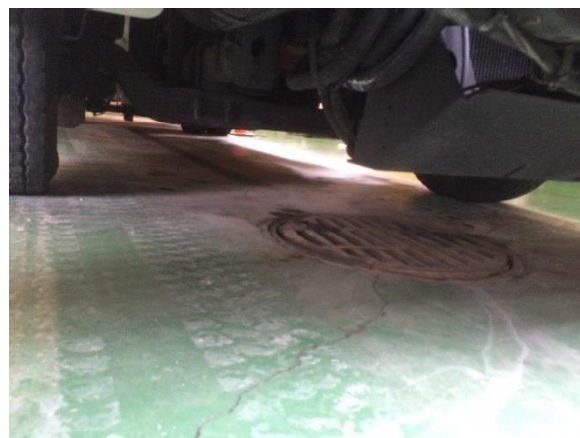
Plumb Pic 9

- Two trucks have trench floor drains with one also having a round grated floor drain. One truck does not have a floor drain. See Plumb pics 9 and 10.
- Oxygen tanks and cylinder tanks are stored in a closet and on shelves. See Plumb pics 11 and 12.

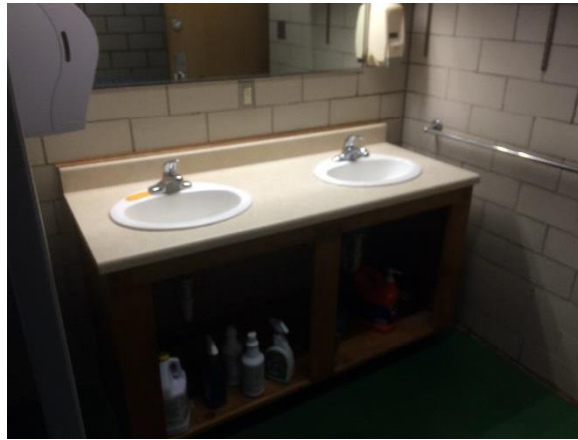
Plumb Pic 13

- The restroom plumbing fixtures are original to the building except for the lavatories. See Plumb pics 13, 14, 15, 16, 17, 18, 19, 20, and 21.
- The building is supplied with low pressure gas service from Dominion. This gas service supplies gas through black steel pipe to the boiler, rooftop units, and barbeque grille. See Plumb pic 22, 23, and 24.

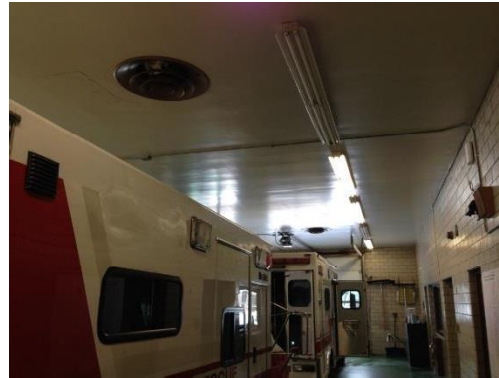
Lighting Pic 2

- It appears the light fixtures in the garage area and work-out room have been updated with linear fluorescent lamped industrial strip fixtures containing T8 lamps. (See Lighting Pics 2, & 3)

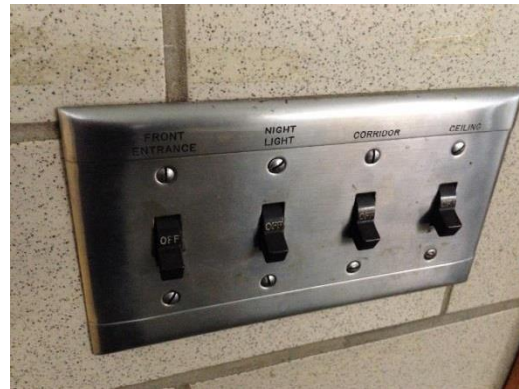
Lighting Pic 4

- The interior lighting appears to be controlled via manual on/off toggle switches. There does not appear to be any automatic lighting controls for the interior lighting fixtures. (See Lighting Pics 4)

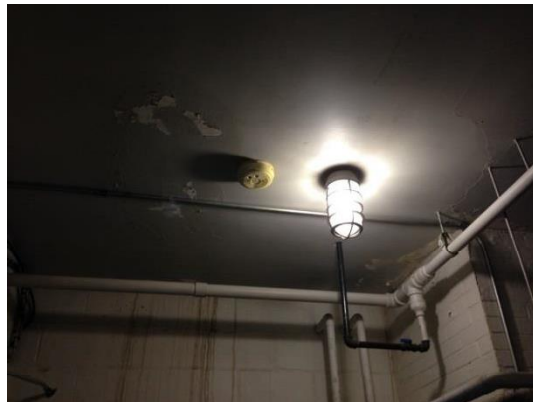
Special Systems 4

- The building appears to have standalone or single/multiple station smoke detectors in a few areas. (See Special Systems Pics 4)
