**PUBLIC INVOLVEMENT AND PRELIMINARY DESIGN OF THE  
REHABILITATION/REPLACEMENT OF THE RIVERFRONT  
BOARDWALK**

**DEVELOPMENT OF A PUBLIC INVOLVEMENT STRATEGY AND  
PRELIMINARY ENGINEERING FOR THE REHABILITATION/REPLACEMENT  
OF THE RIVERFRONT BOARDWALK**

The City of Cuyahoga Falls owns and maintains a riverfront boardwalk structure running along the west bank of the Cuyahoga River, near the downtown Falls River Square area. At the request of the City, Palmer Engineering performed a field inspection of the boardwalk structure in October and November of 2019. During the inspection, pier settlement and joist hanger failures were observed which compromise the safety of the public. Due to these observations, Palmer recommended partial closure of the boardwalk in the areas of concern, and the City closed the recommended areas shortly thereafter.

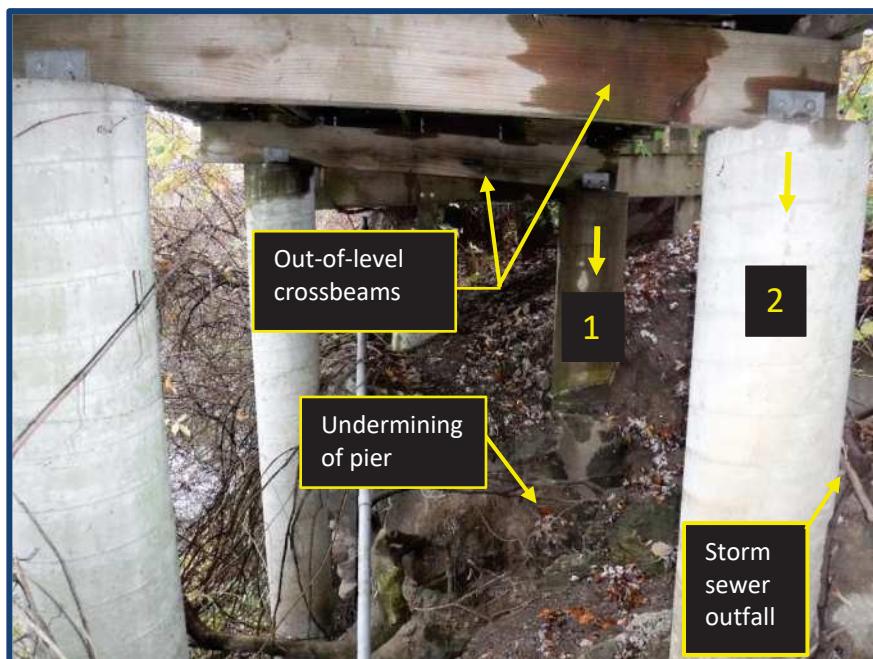
**Description:** Slope erosion and undermining of two concrete piers was observed at this location. The erosion appears to be due to a storm sewer outfall directly above the piers. The erosion has caused the piers to settle by an estimated 4"-6", as evidenced by out-of-level of the crossbeams and loss of contact between the stringers and crossbeam. In addition, there are large voids beneath one of the piers.

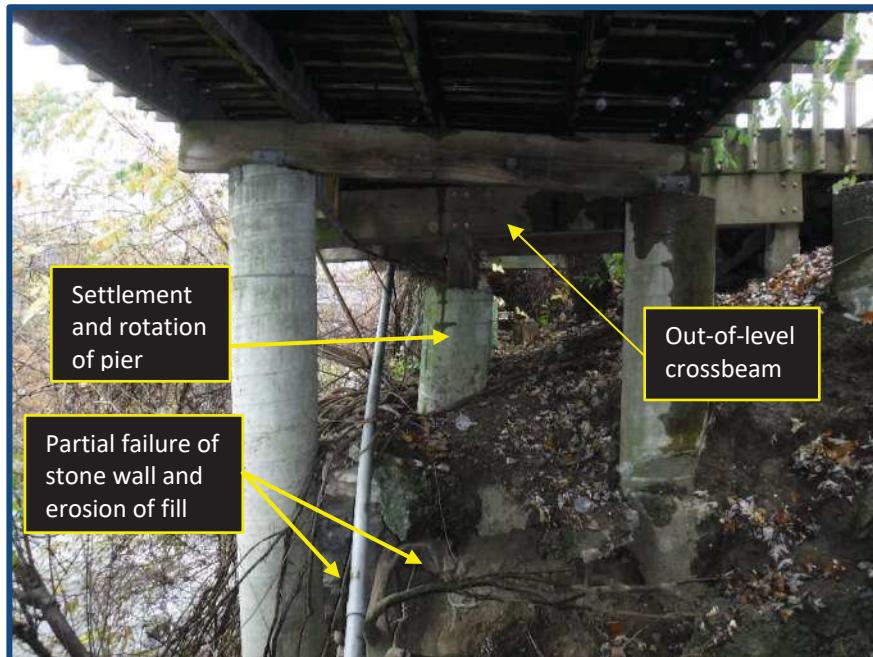
**Description:** Slope erosion and subsidence, and rotation and partial failure of an existing stone wall retaining fill was observed. The retained fill appears to support five piers which in turn support the east portion of the observation deck. The observed subsidence and erosion of the fill has caused settlement of the four north most piers, as evidenced by shimming required to maintain the deck in a level position. Up to approximately 3" of pier settlement has occurred at the worst location.

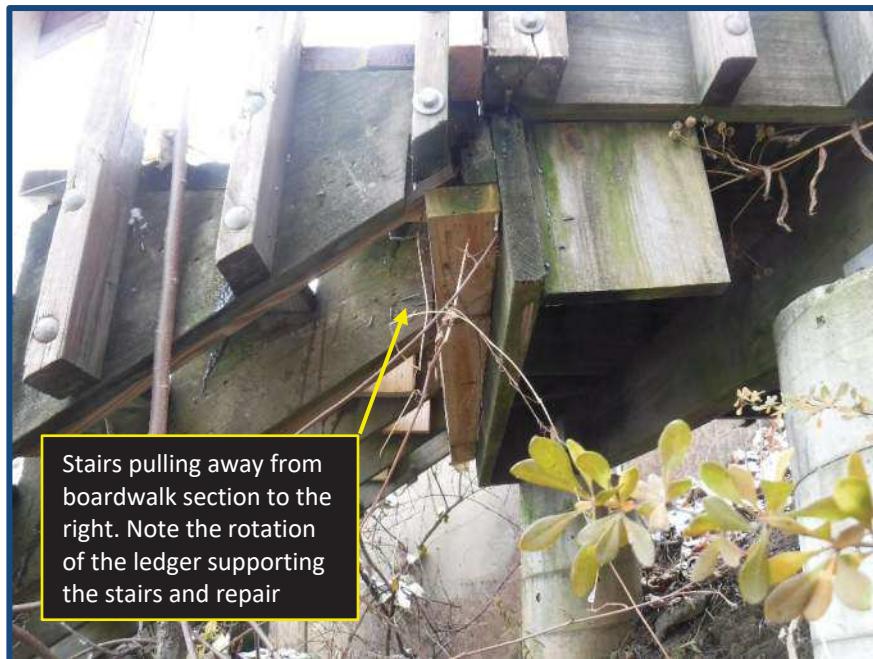
**Description:** Racking of the stairs, separation of the stairs from the boardwalk, and possible settlement of the pier at the base of the stairs was noted at the location described below.

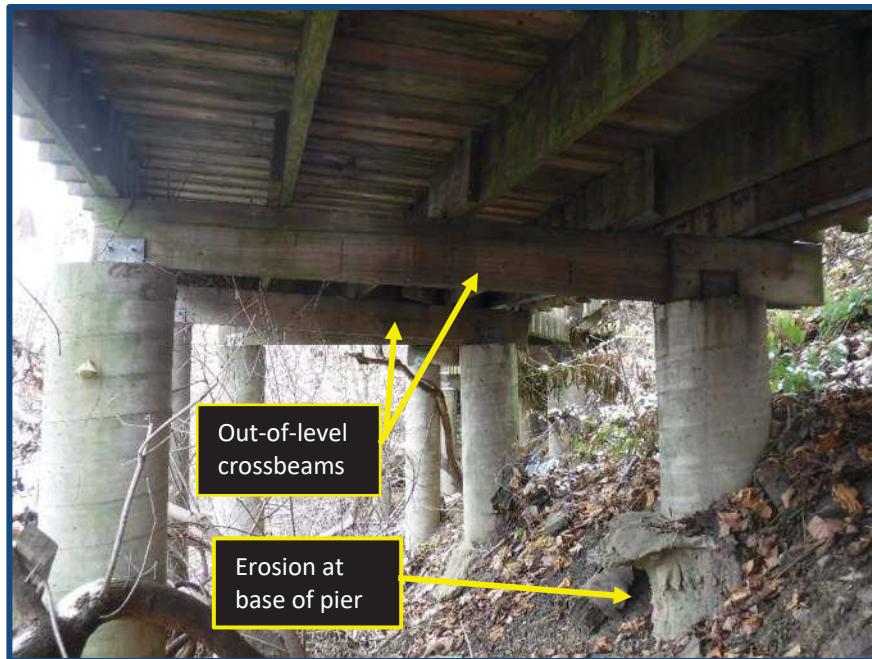
**Description:** Possible settlement of two adjacent piers was noted at the location below, based on out of level crossbeams

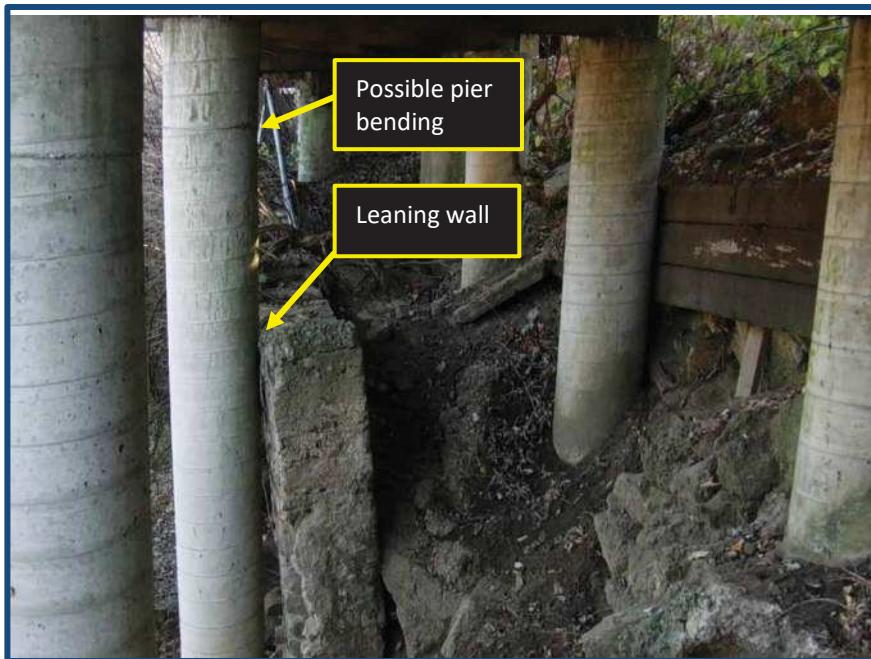
**Inspection Finding Number: 7**

**Description:** A leaning wall is contacting a pier column, possibly introducing bending in the pier.

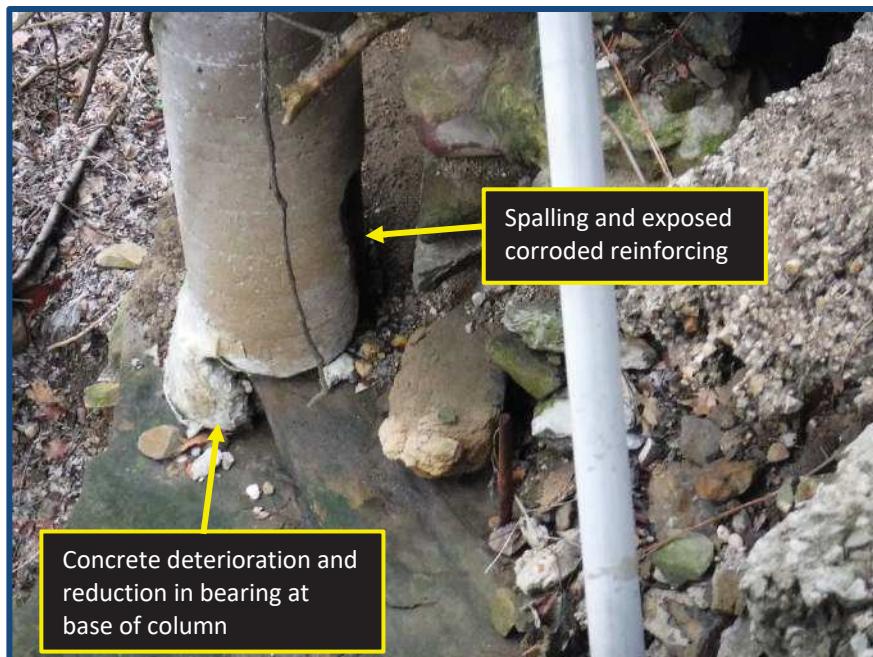
**Description:** Concrete deterioration was observed at the base of a pier in Section 2. The observed deterioration has reduced the bearing area of the pier and exposed reinforcing steel.

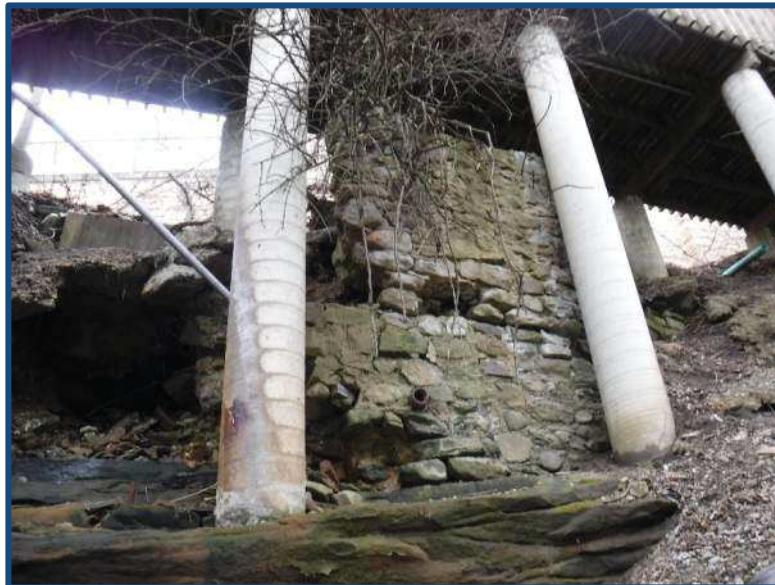
**Description:** Existing stone walls along Section 2 exhibit varying degrees of deterioration. The deterioration is compromising the stability of the walls and the uphill slopes retained by the walls. Also reference inspection findings 2 and 7.
